Centrifugal Pump Explosions

“Rise of the machines”

Brian P. O’Connor

16 March 2006

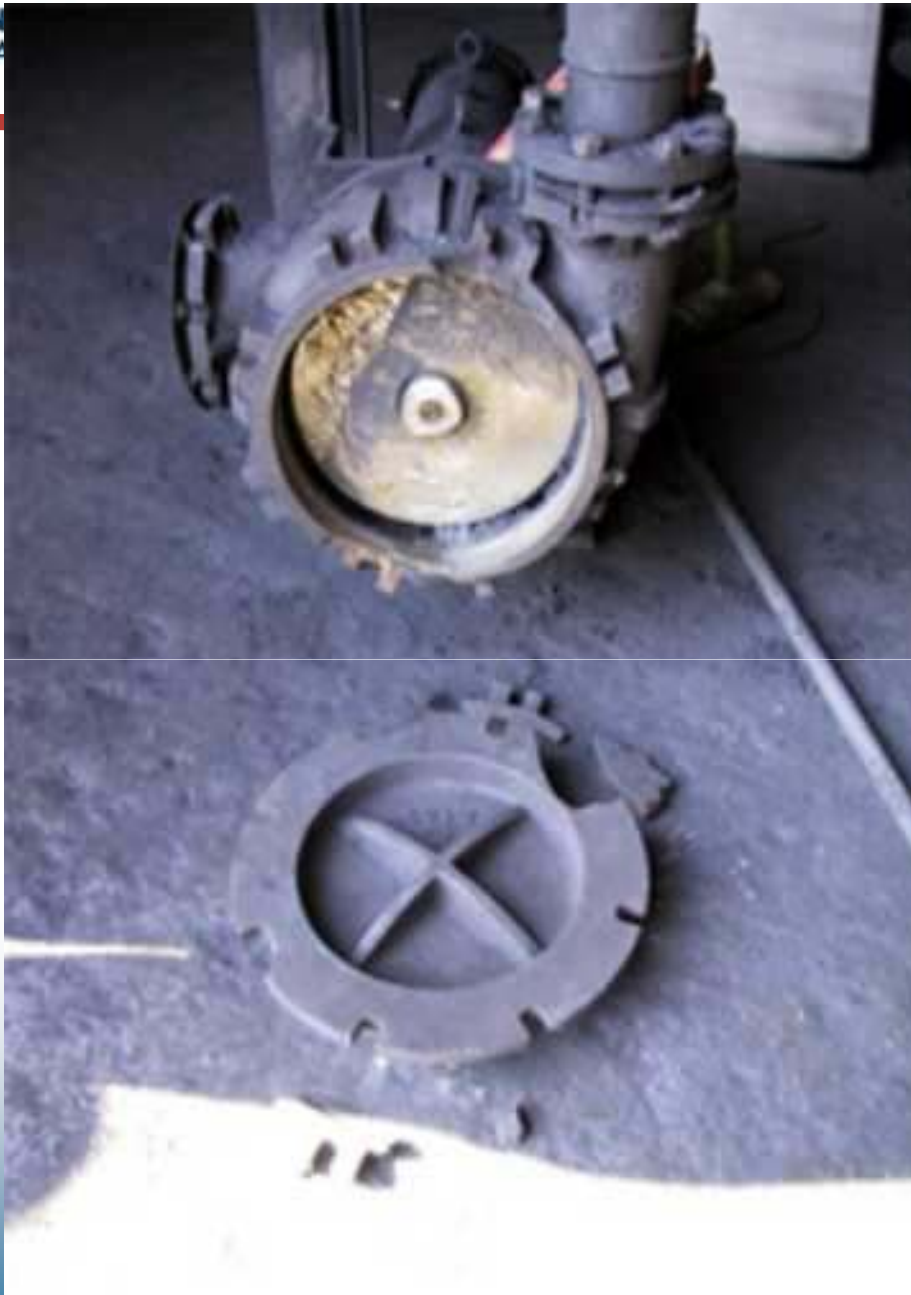
All-metal coal fines transfer pump that exploded killing its Operator.

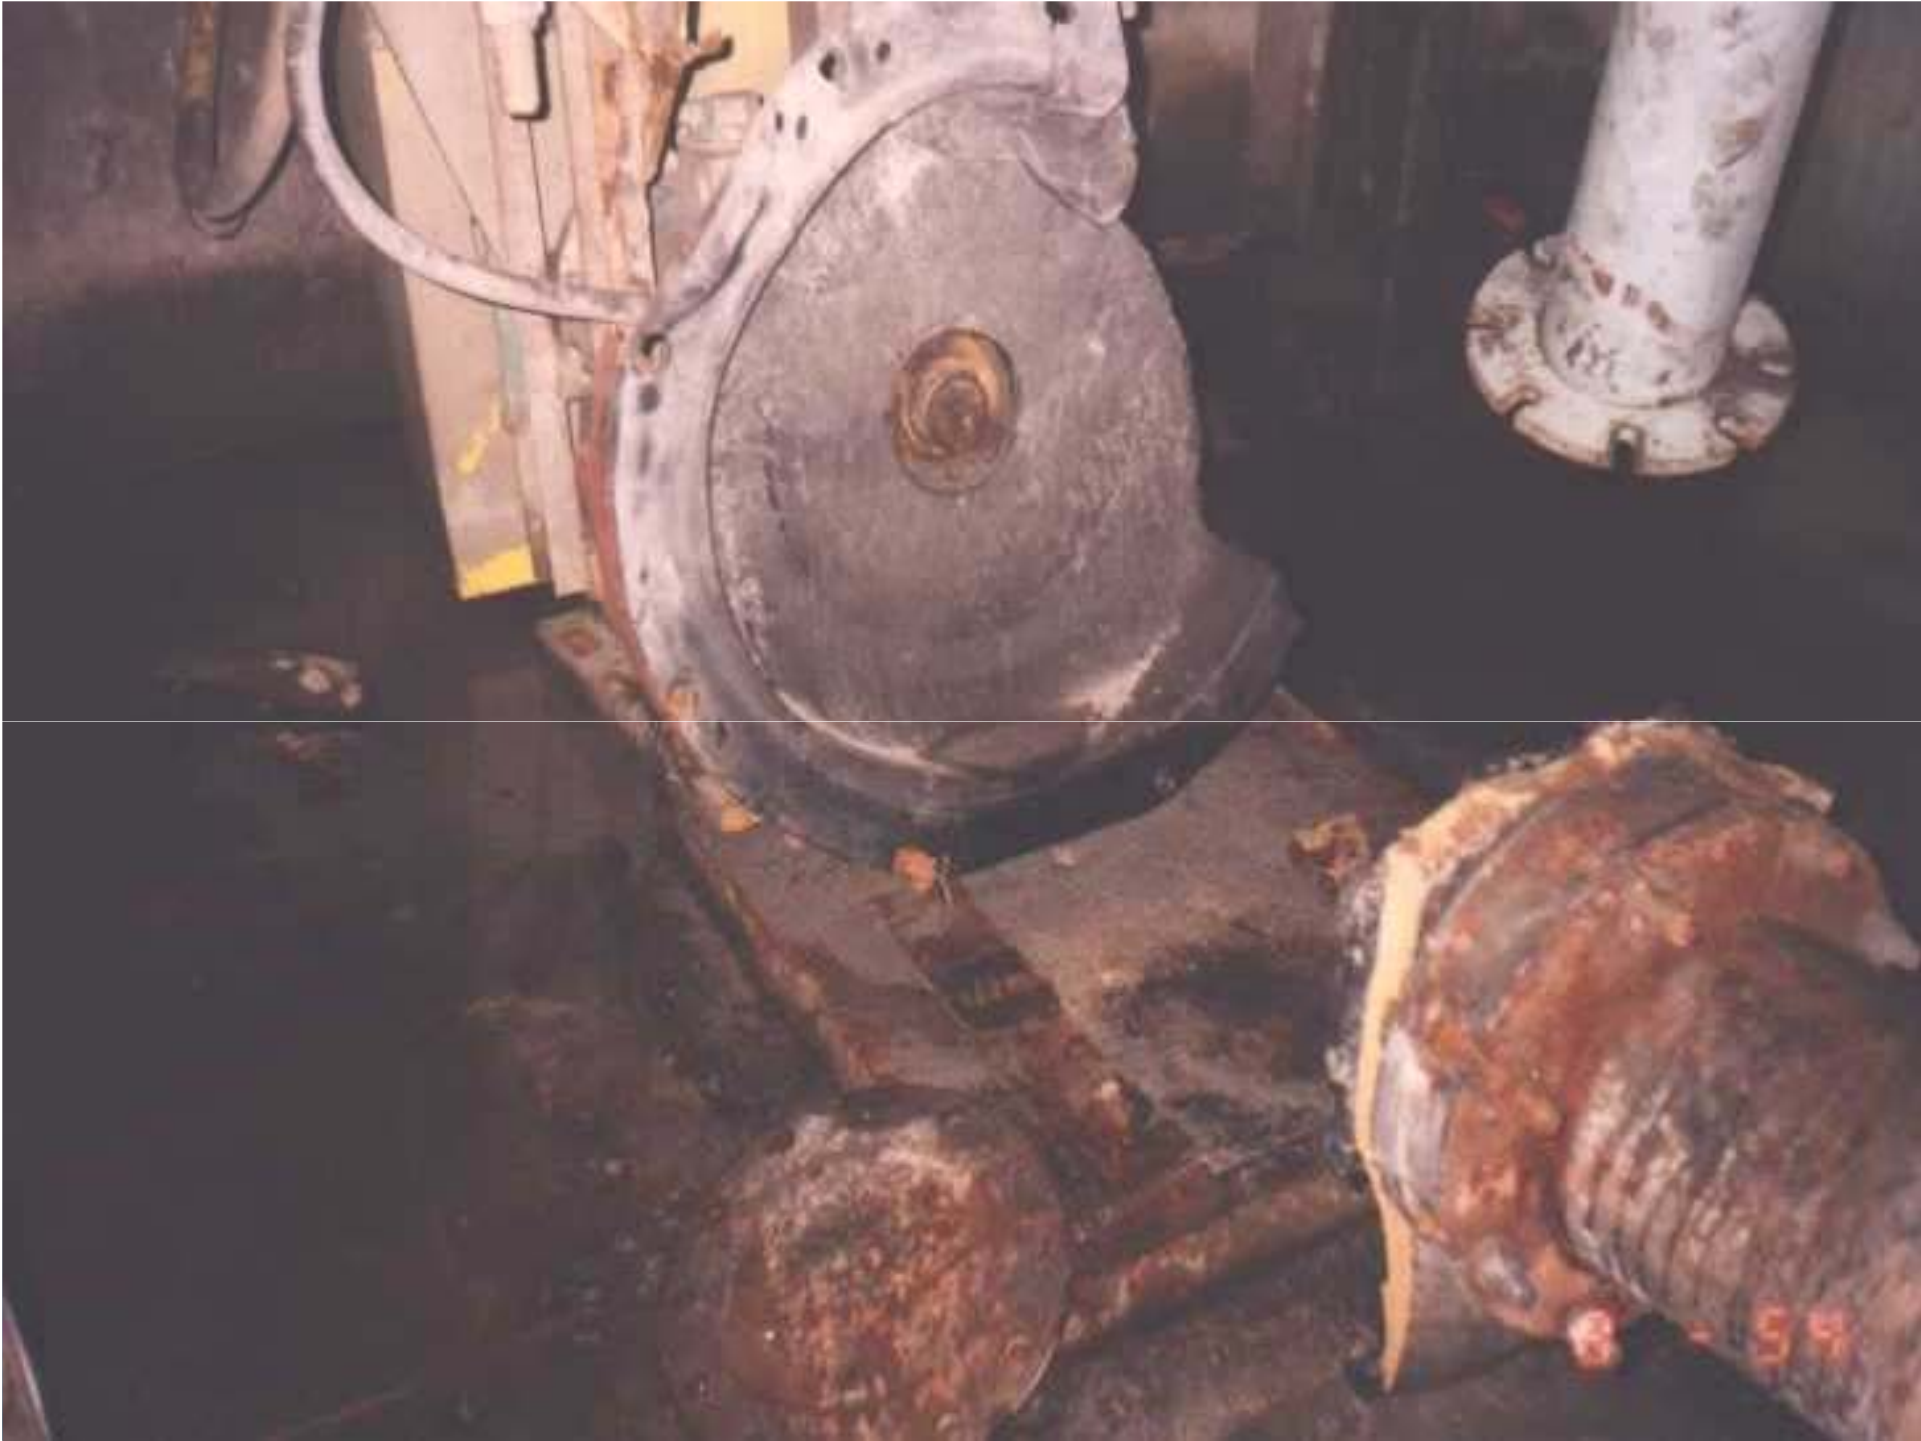
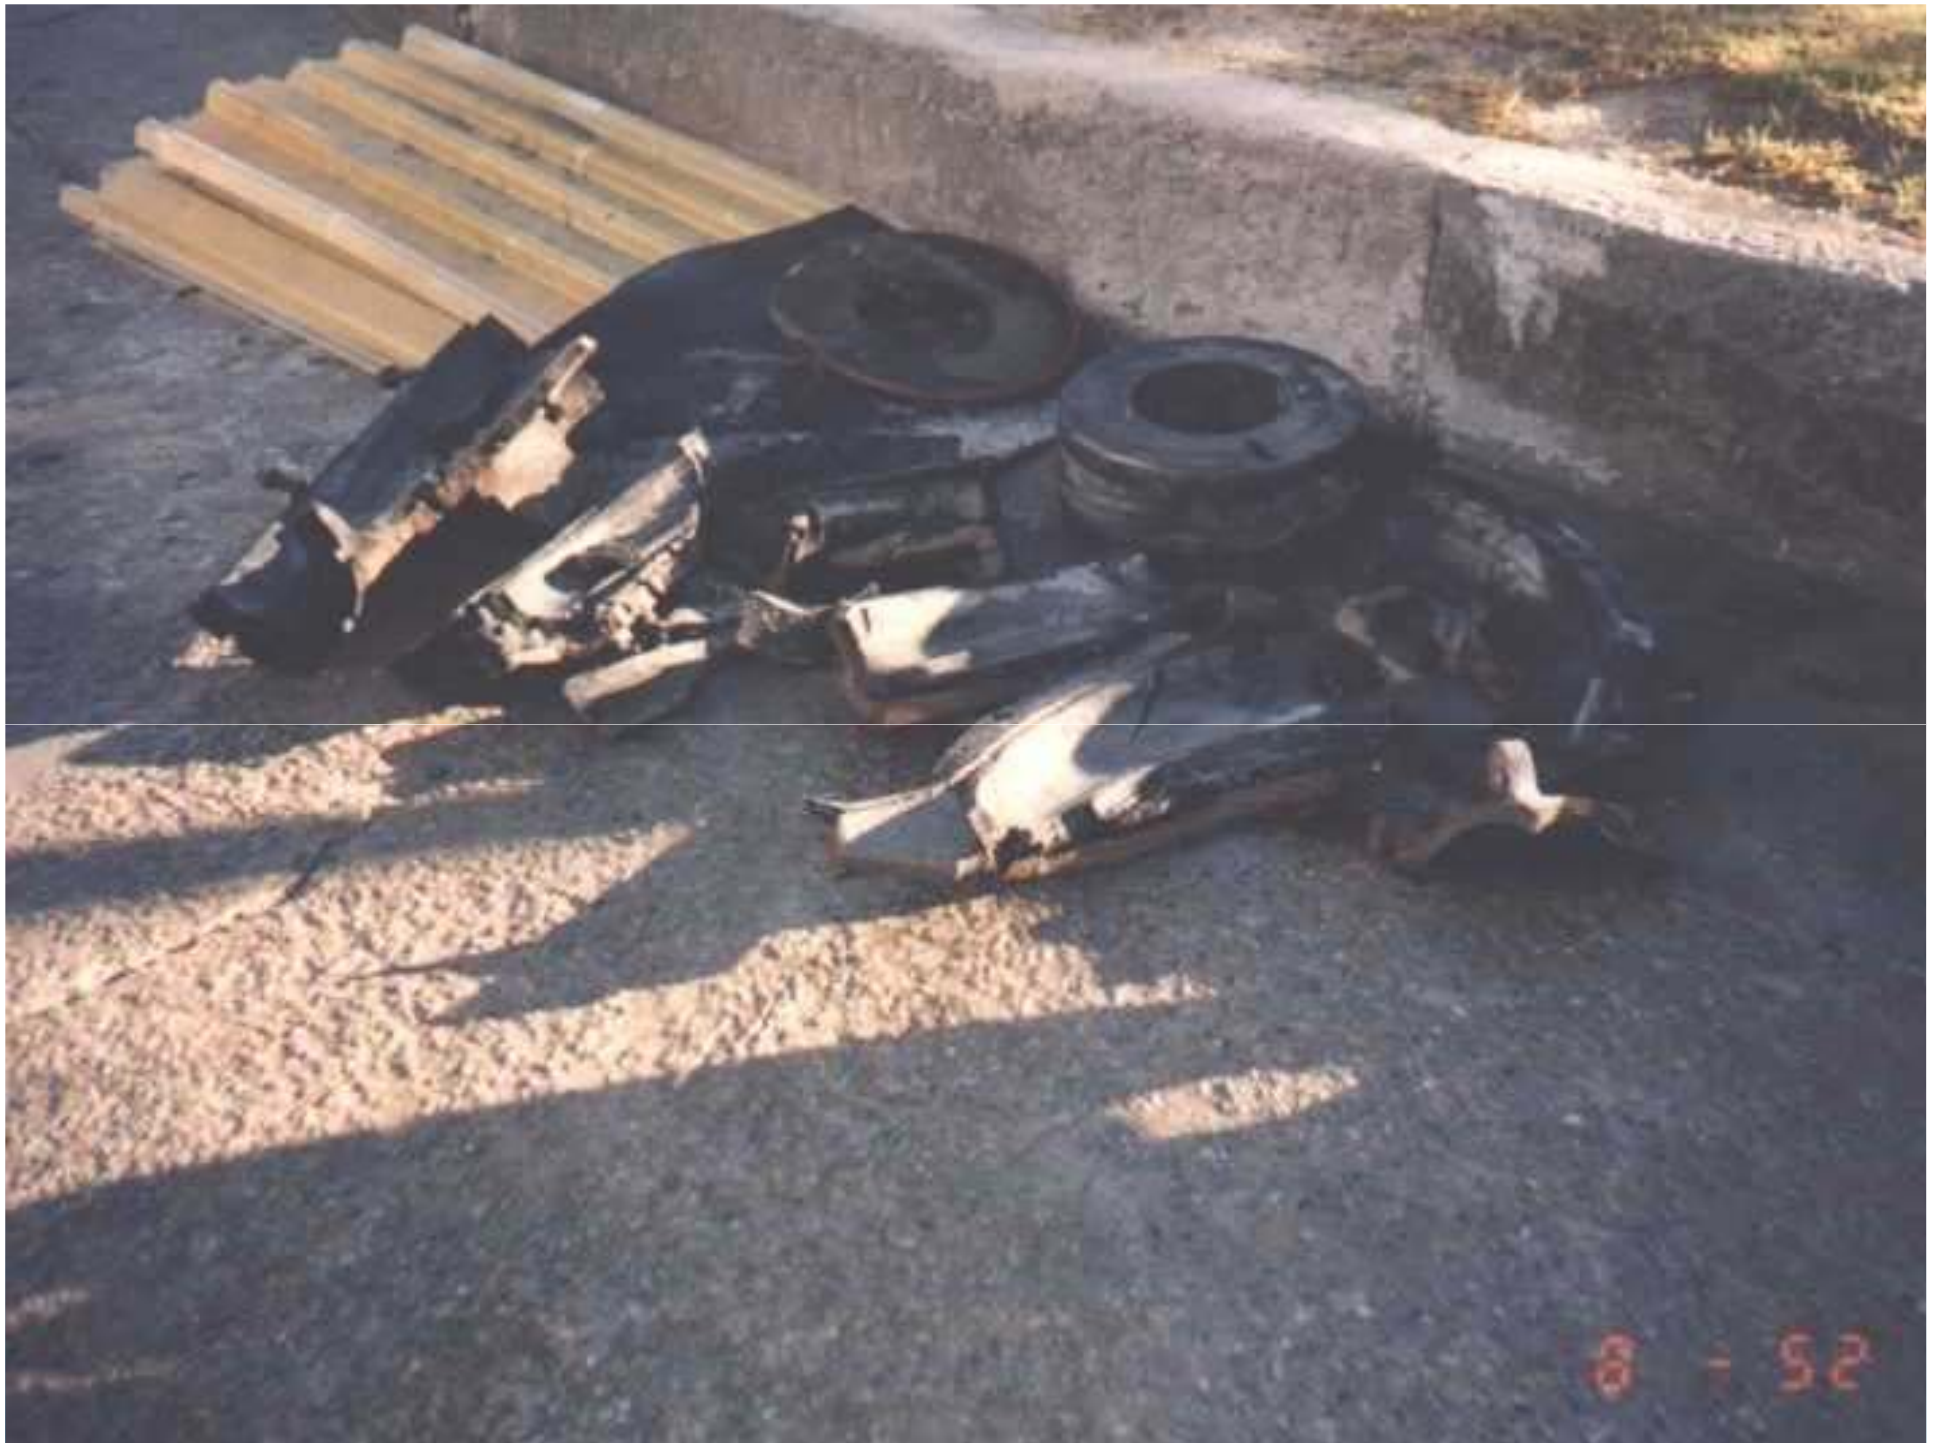
4. Underground at US mine. Explosion felt 280m away. 80kg of pump material was not found.
5. Fatal in Australia when a Warman pump exploded. No records.
6. Bong Mine Liberia. 14/12 pump exploded destroying pump house roof.
7. No.8 Gold plant, AngloGold CD frame water pump
- 2000

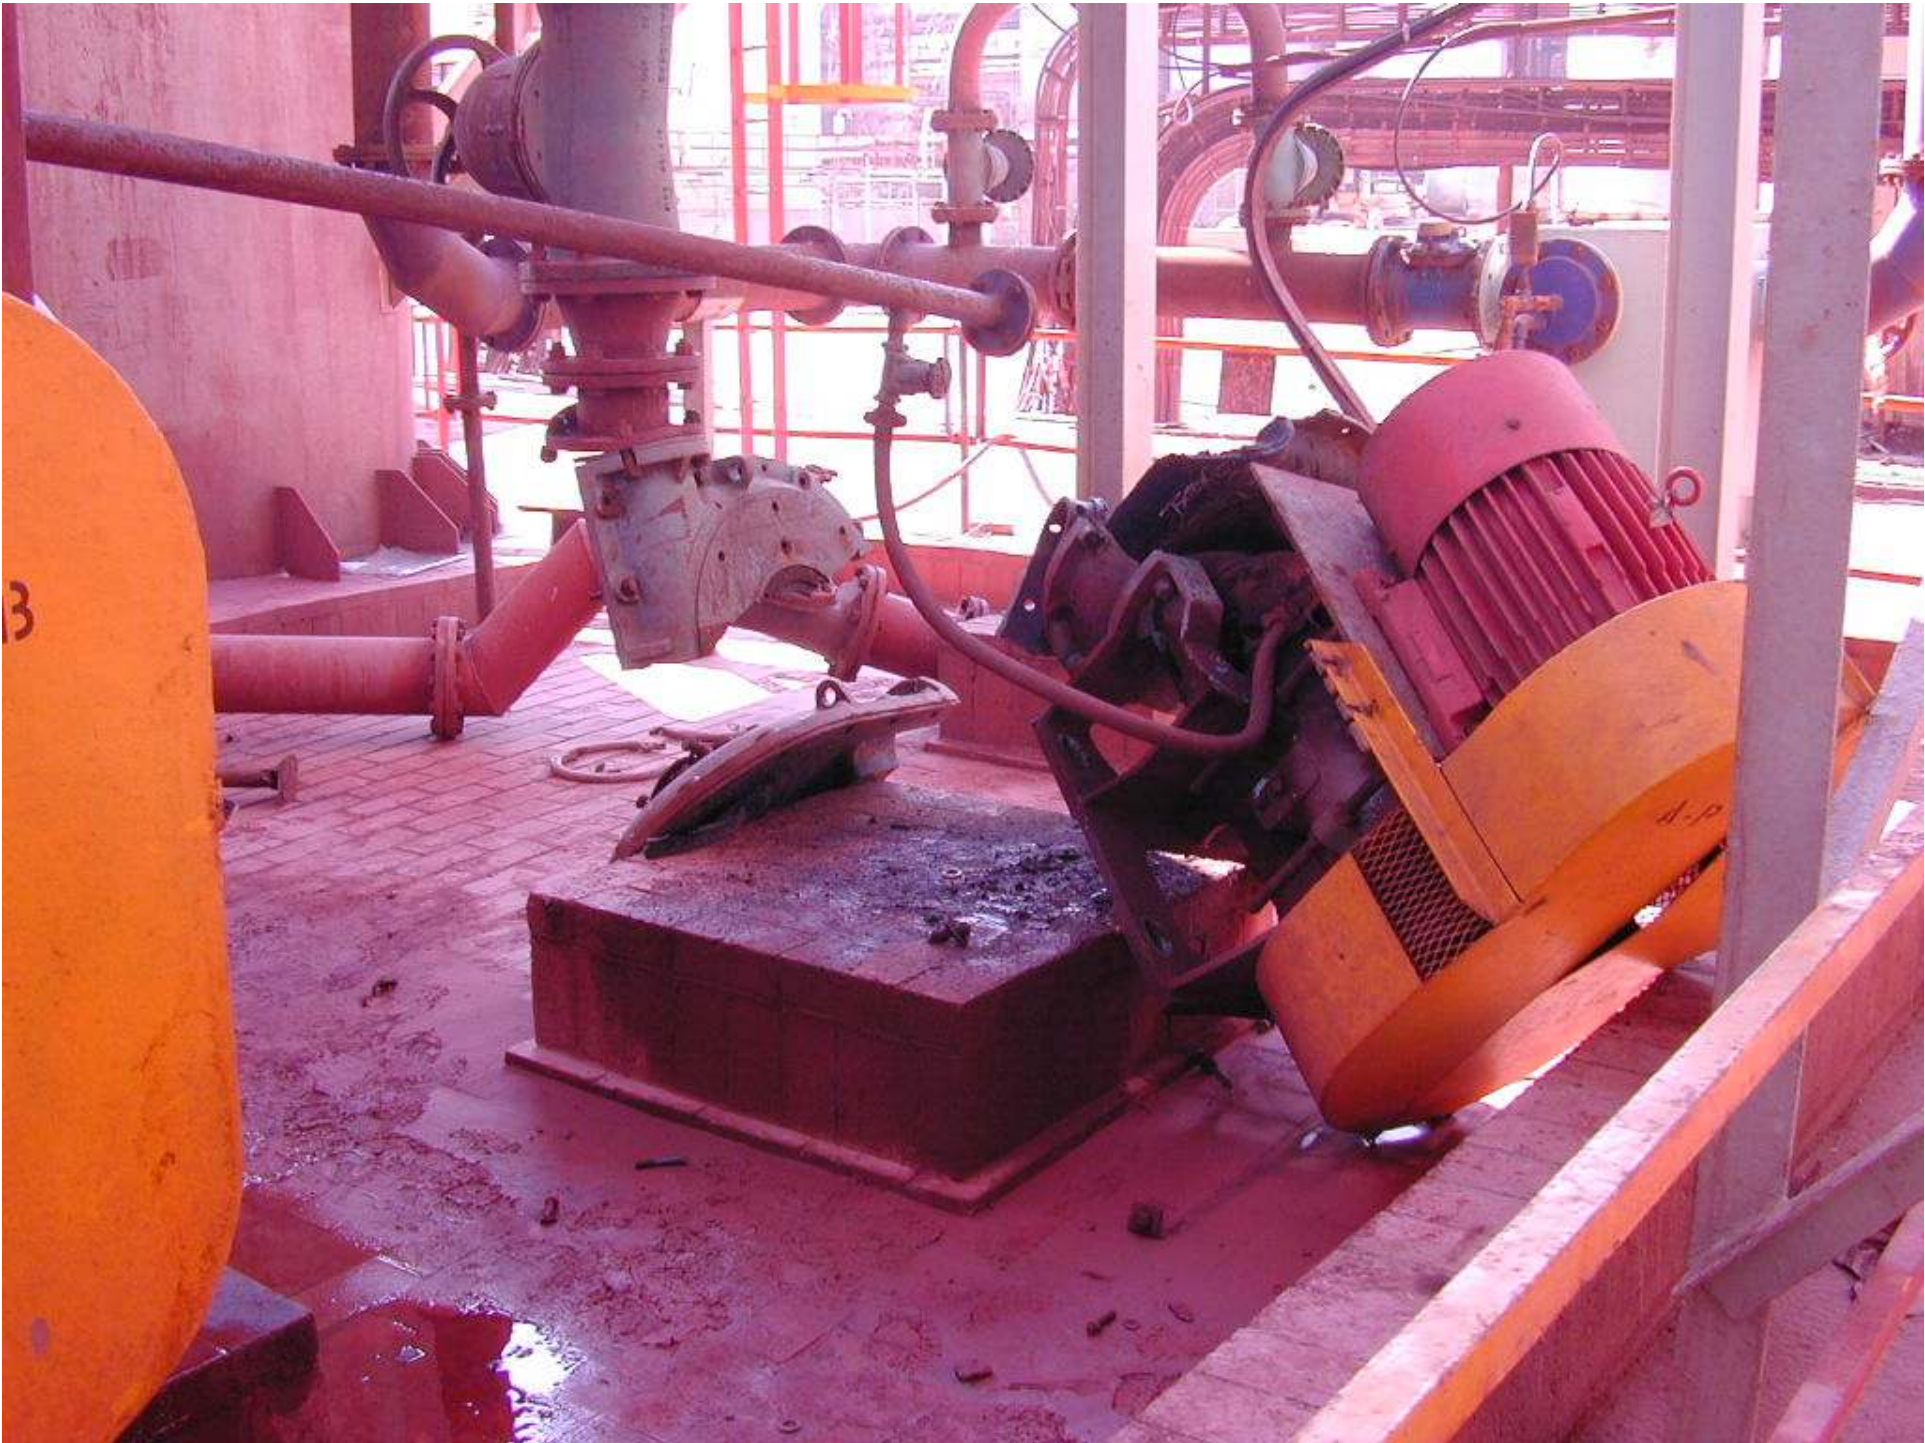
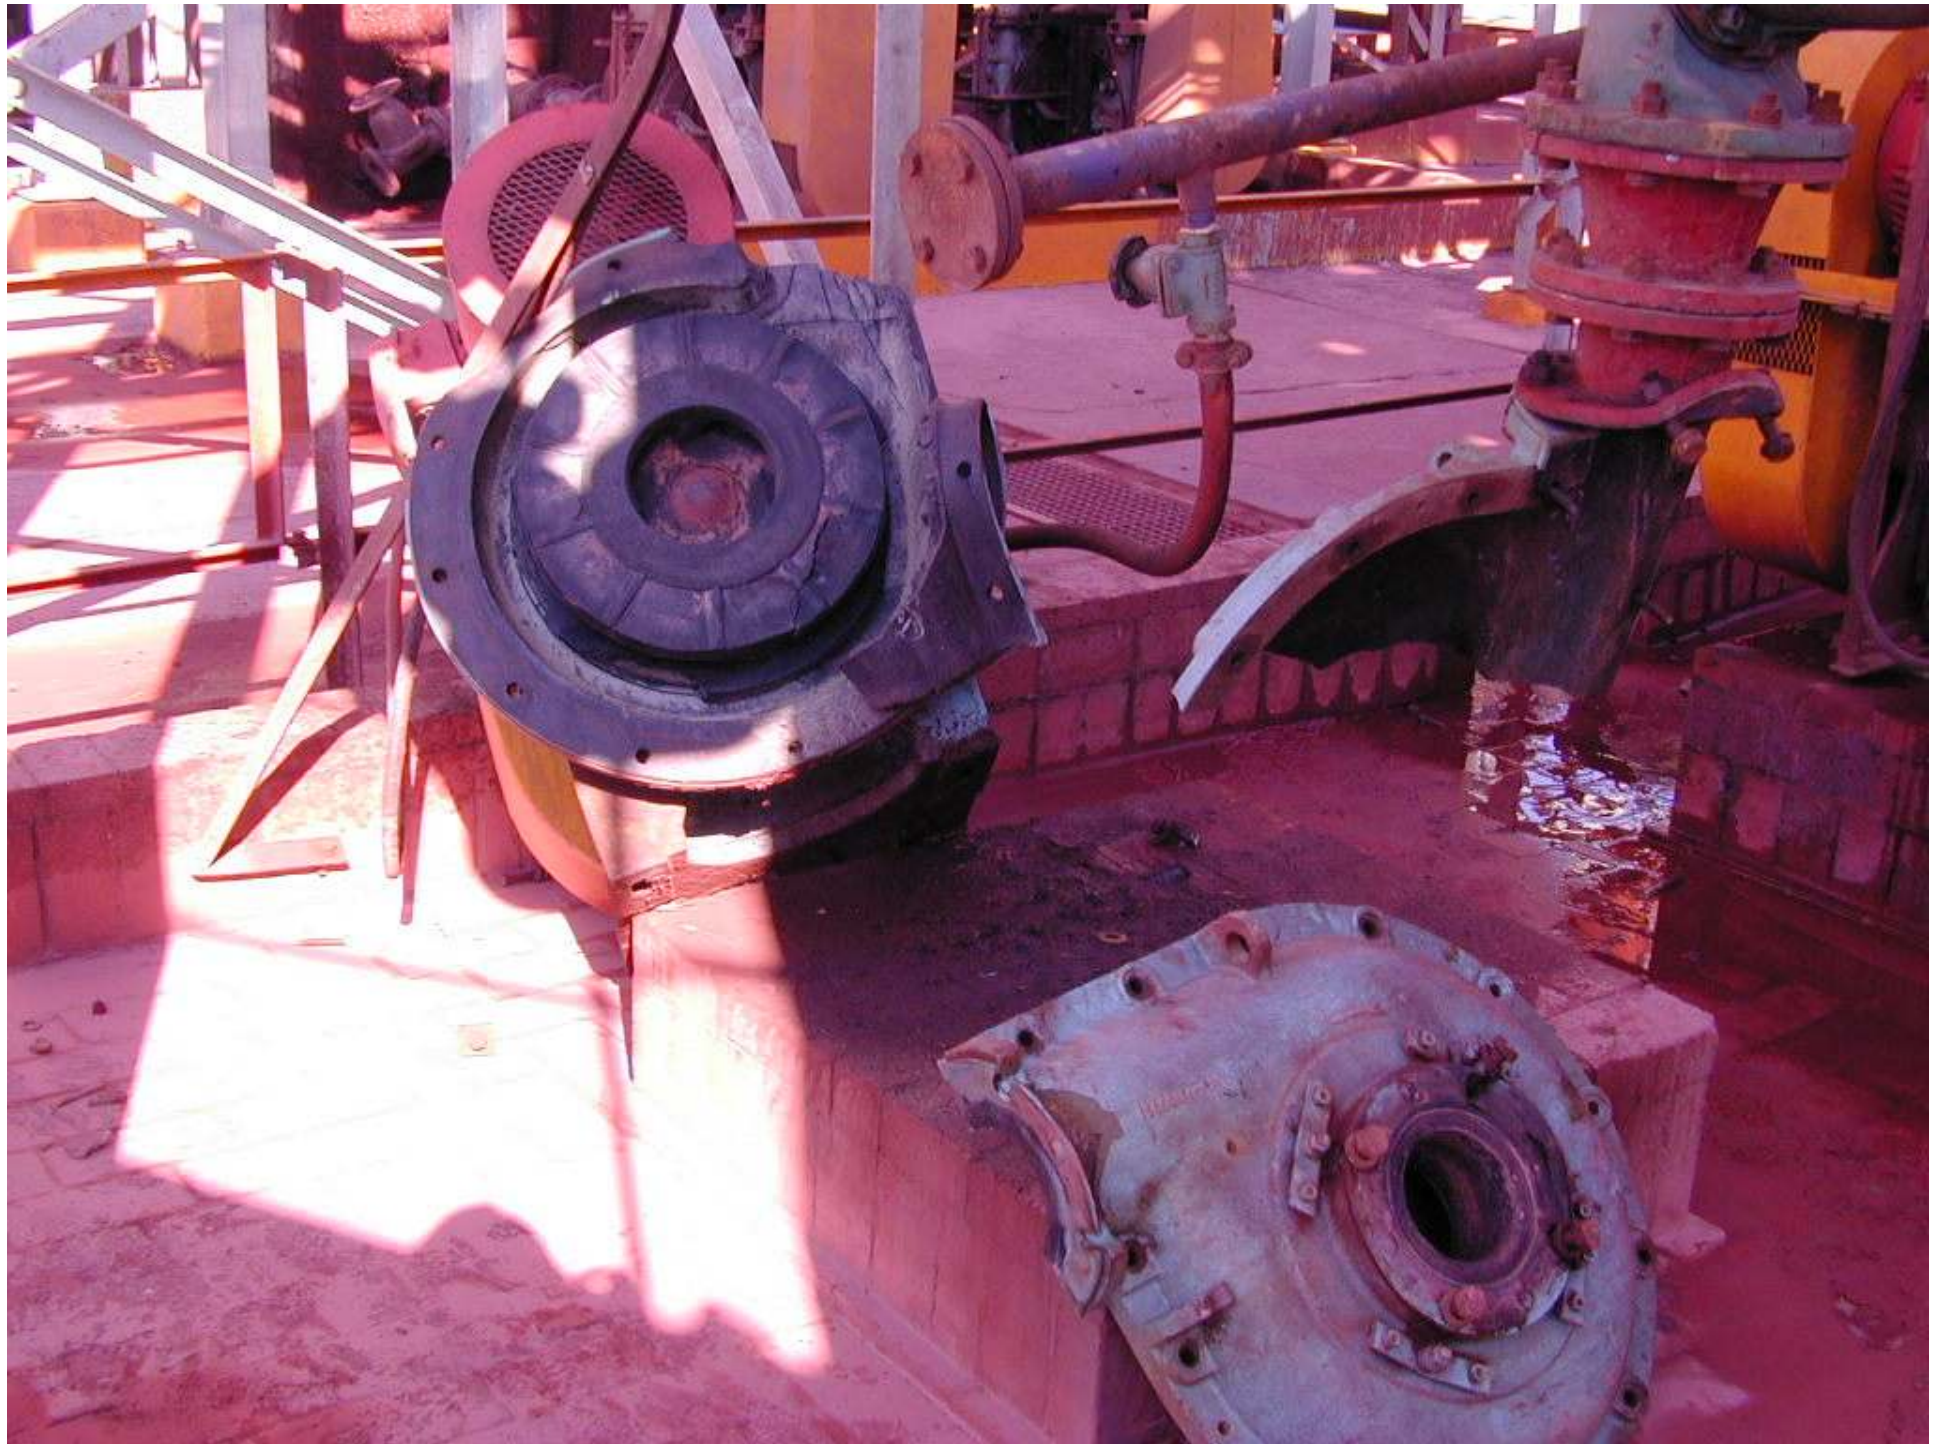
8. North 2 Gold Plant - November 2001.
Cyanide transfer pump.

9. West Float & Acid Plant - February 2001.
Calcine water pump.

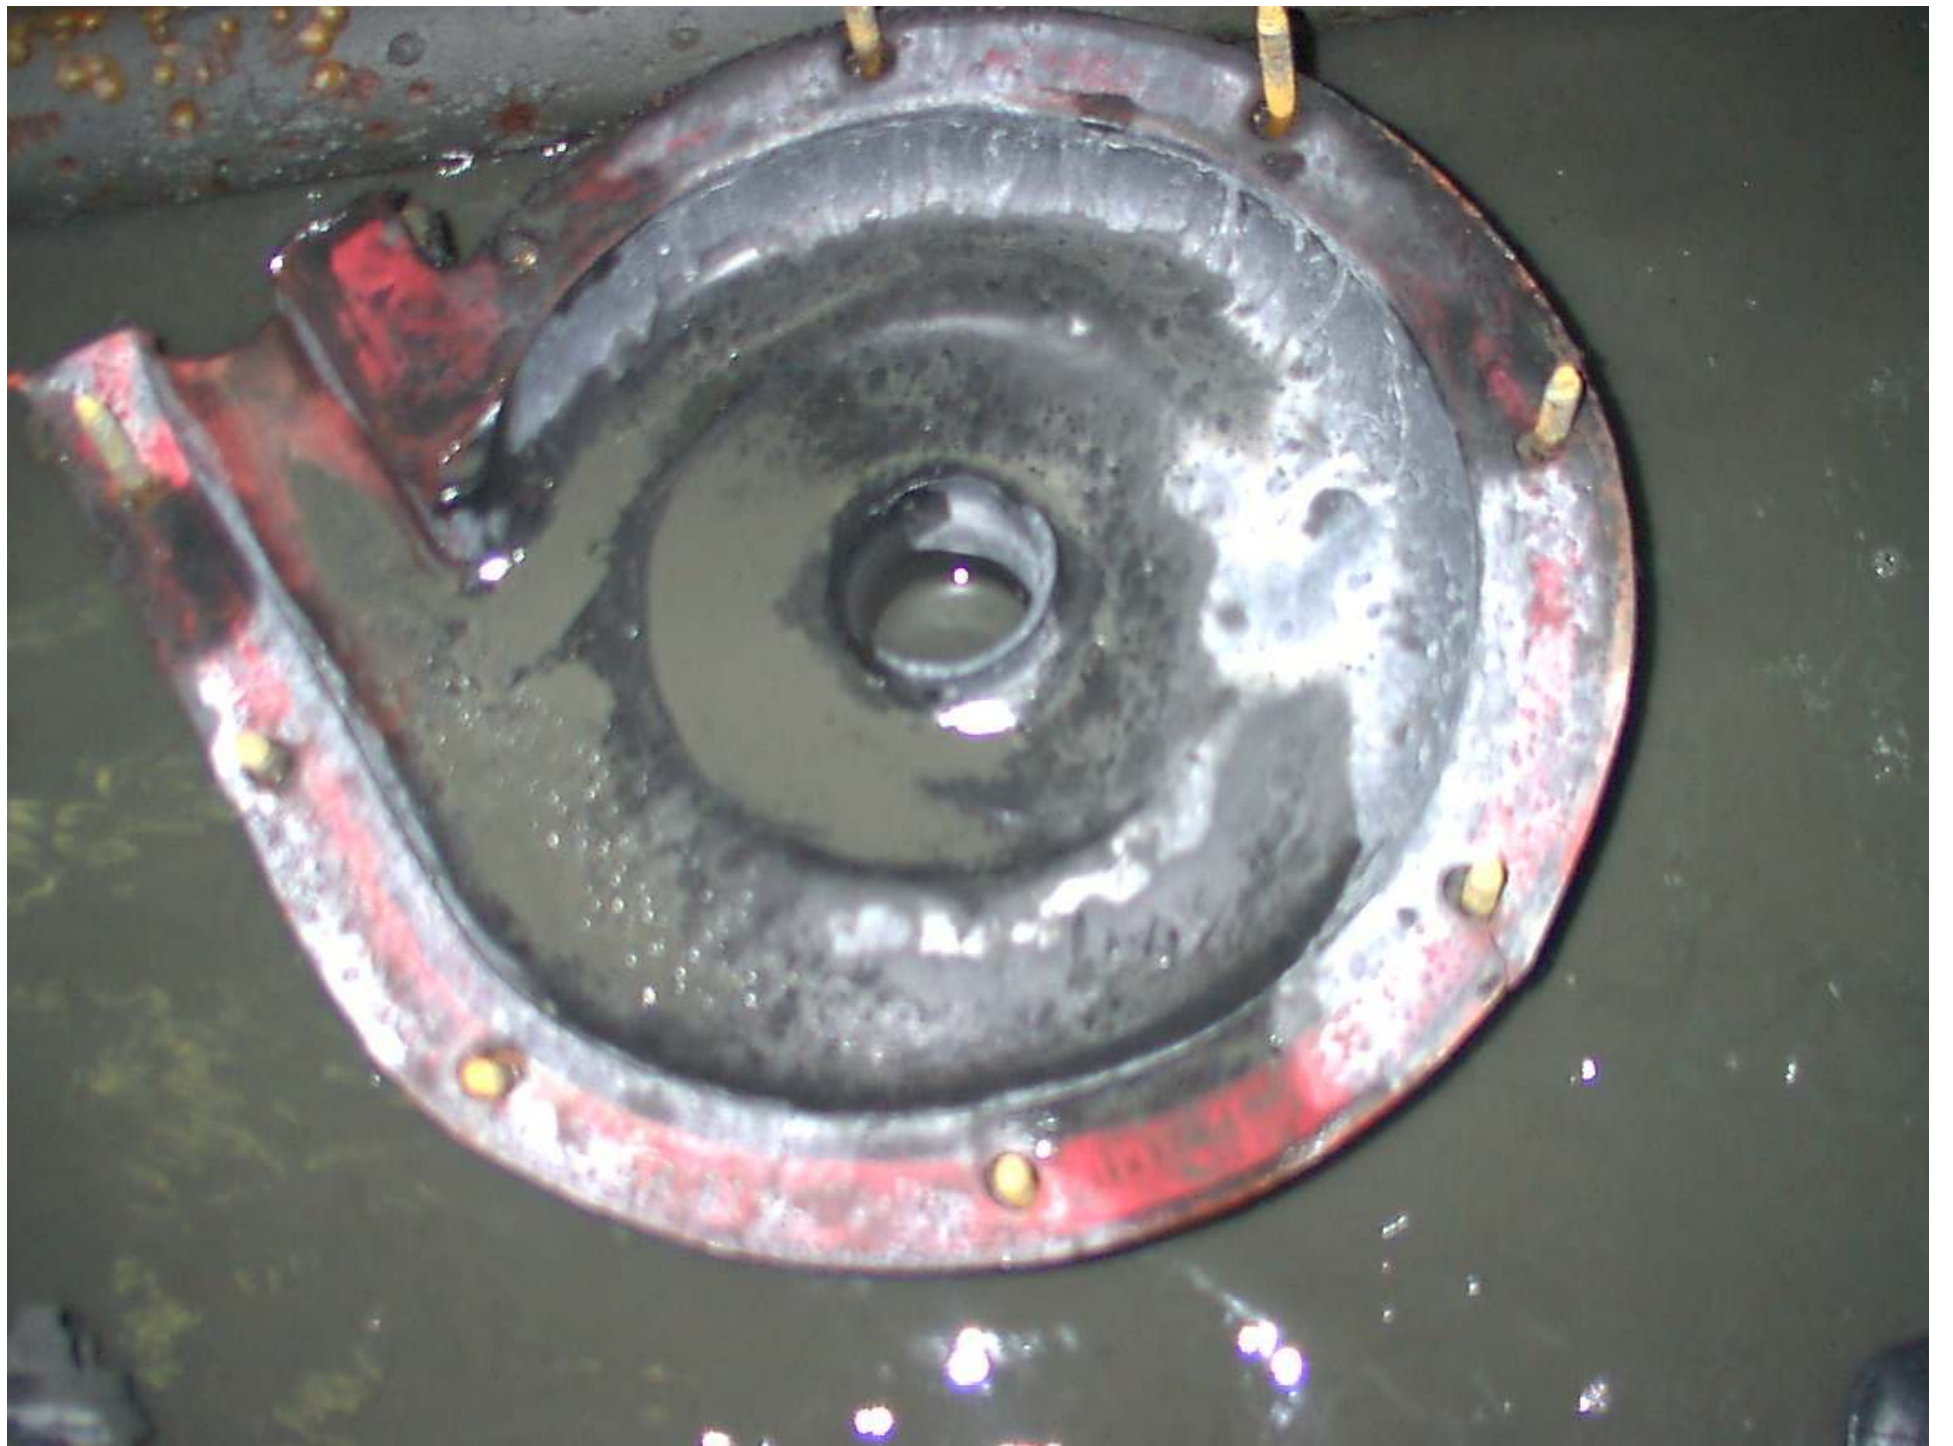
10. North 1 Gold Plant – January 2003
Carbon transfer pump

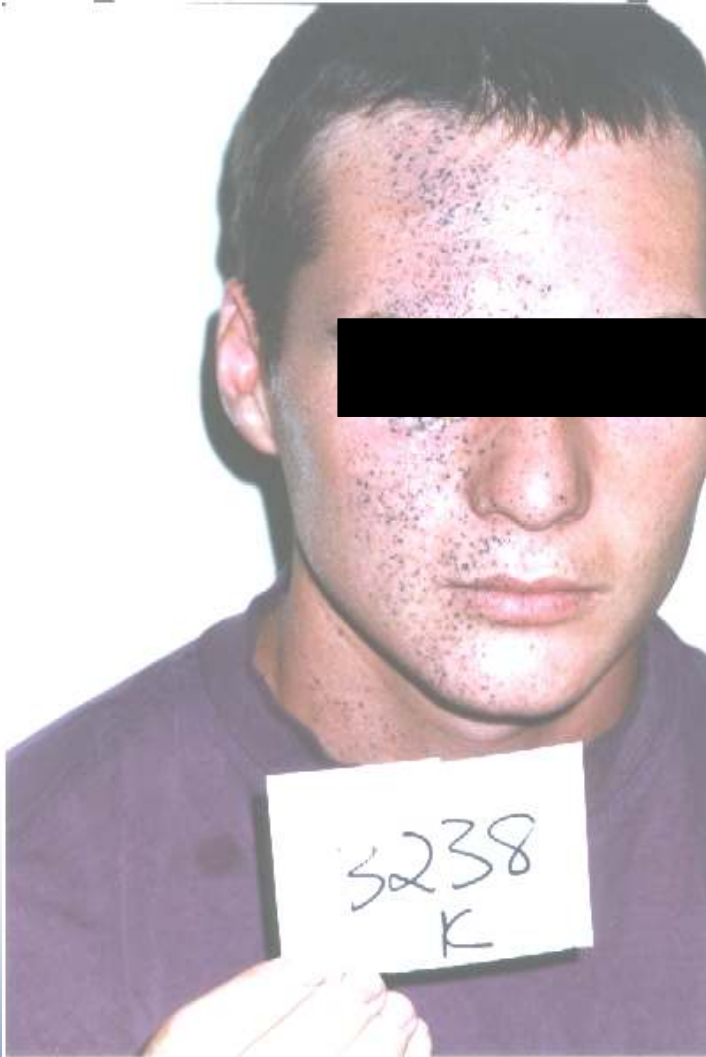
Apprentice with facial injuries from carbon transfer pump burst.
