Centrifugal Pump Explosions

“Rise of the machines”

Brian P. O’Connor

16 March 2006

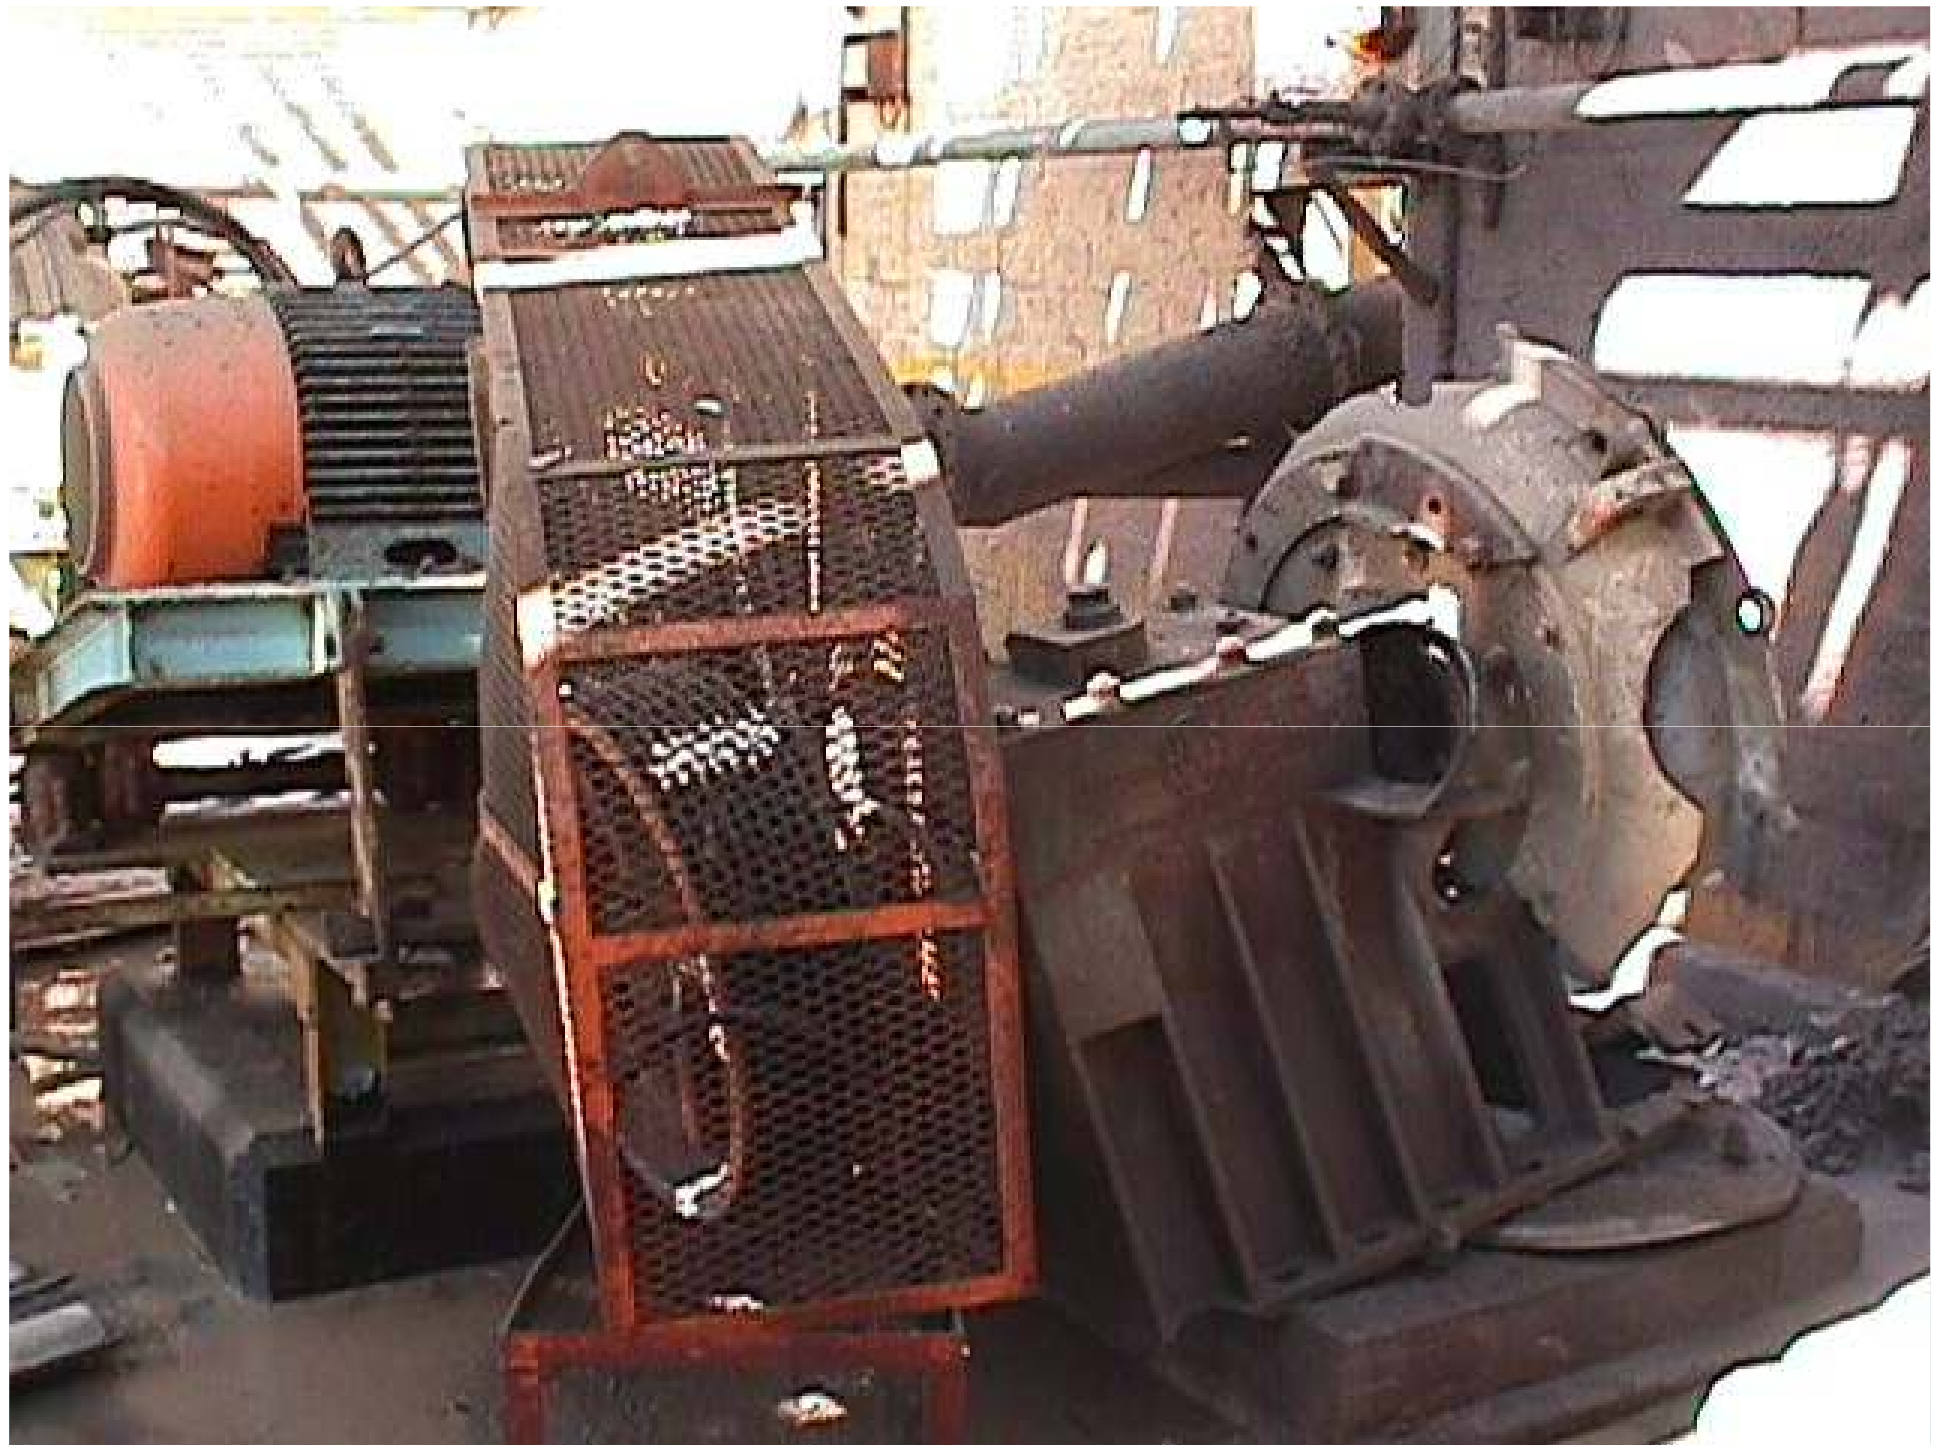
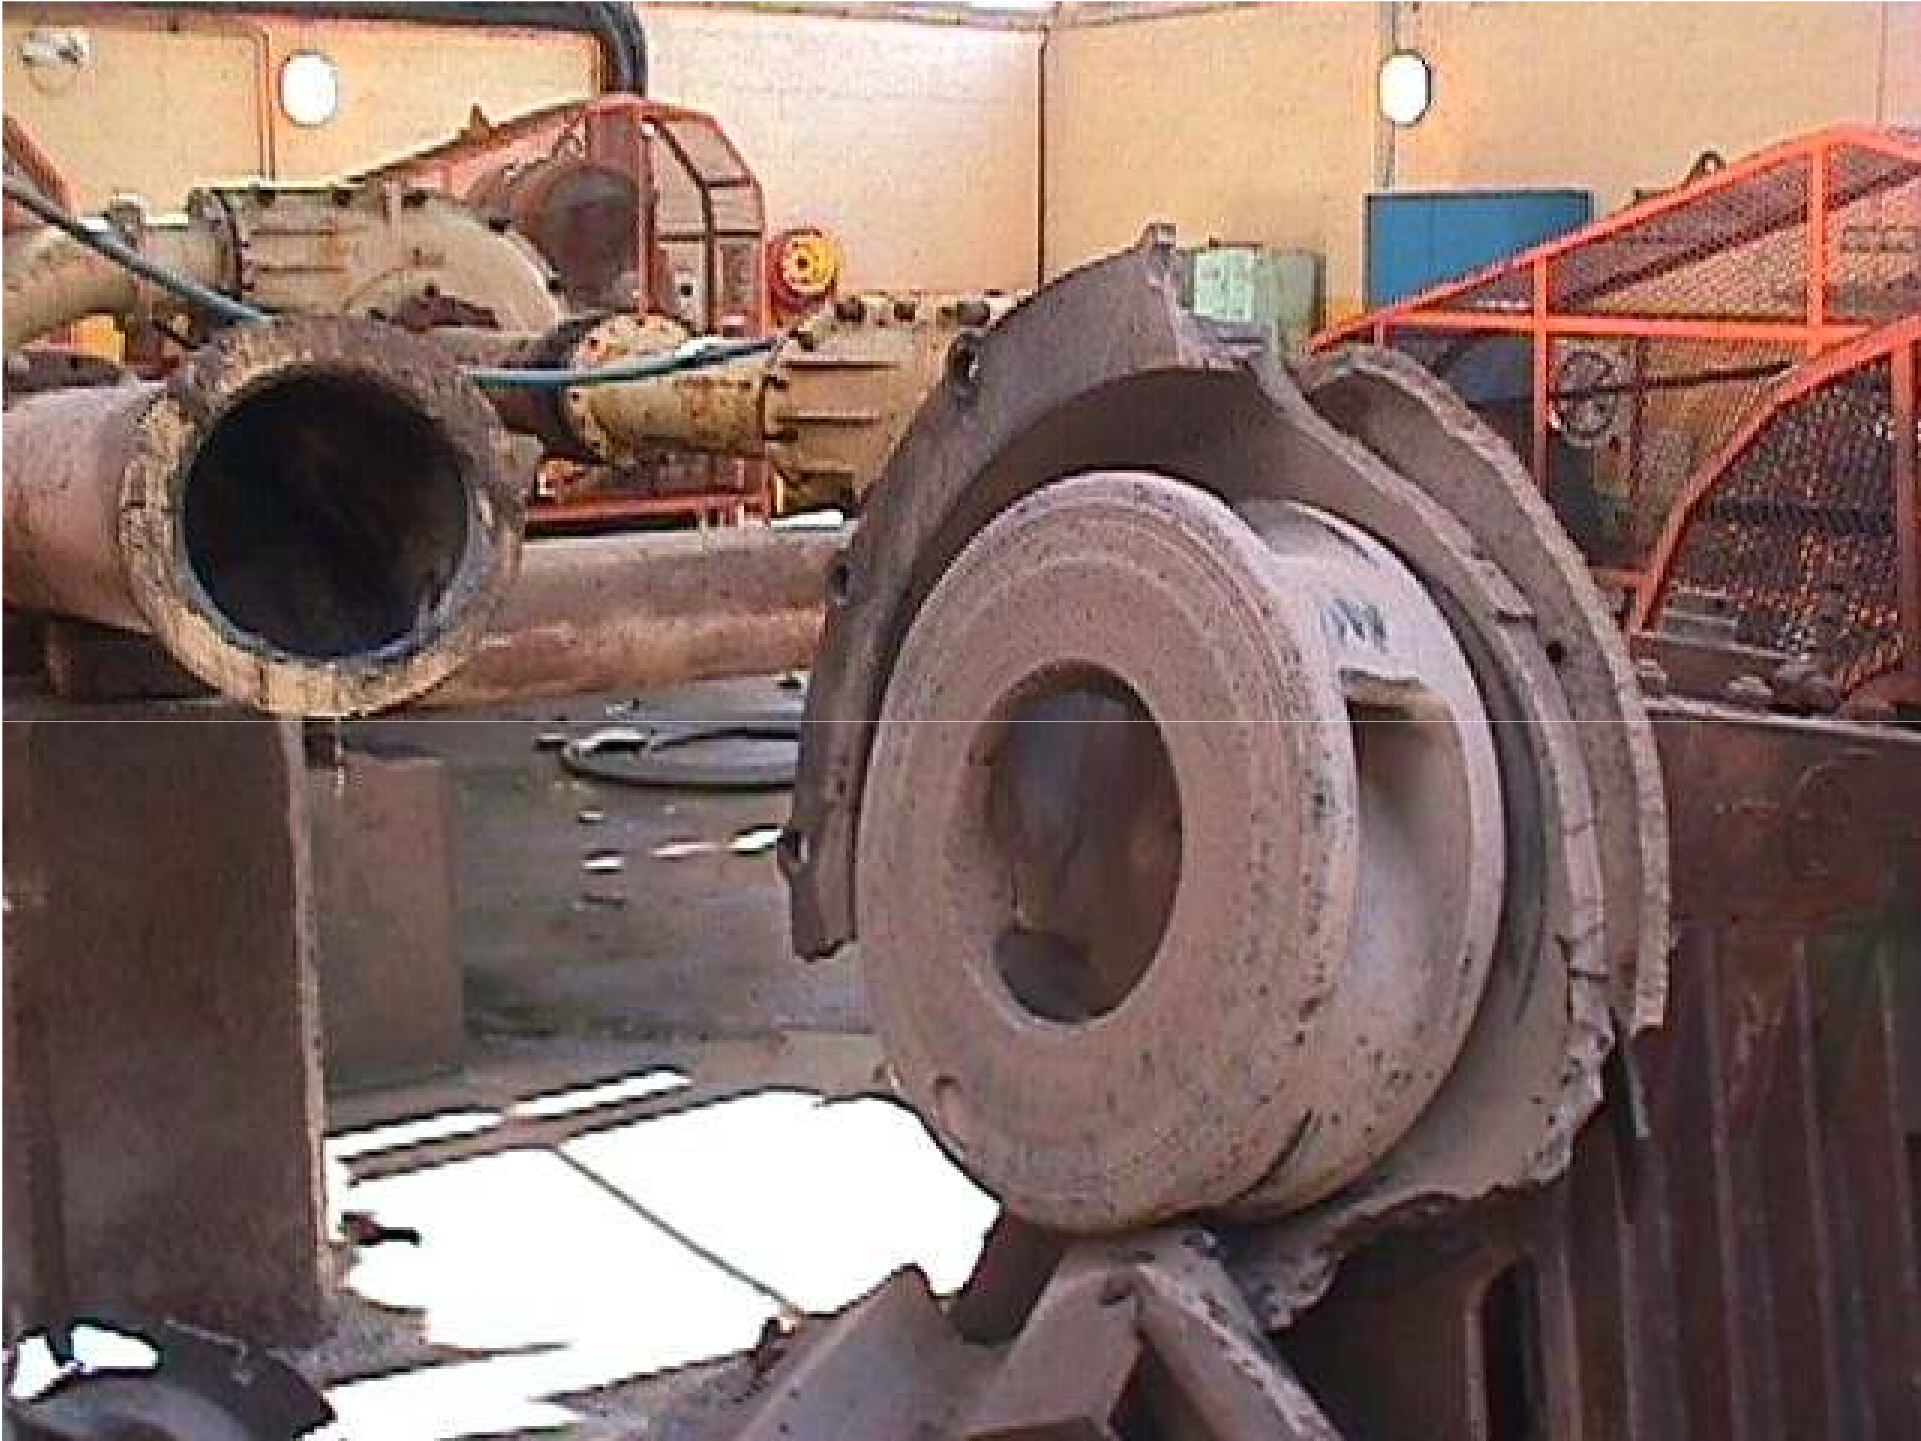
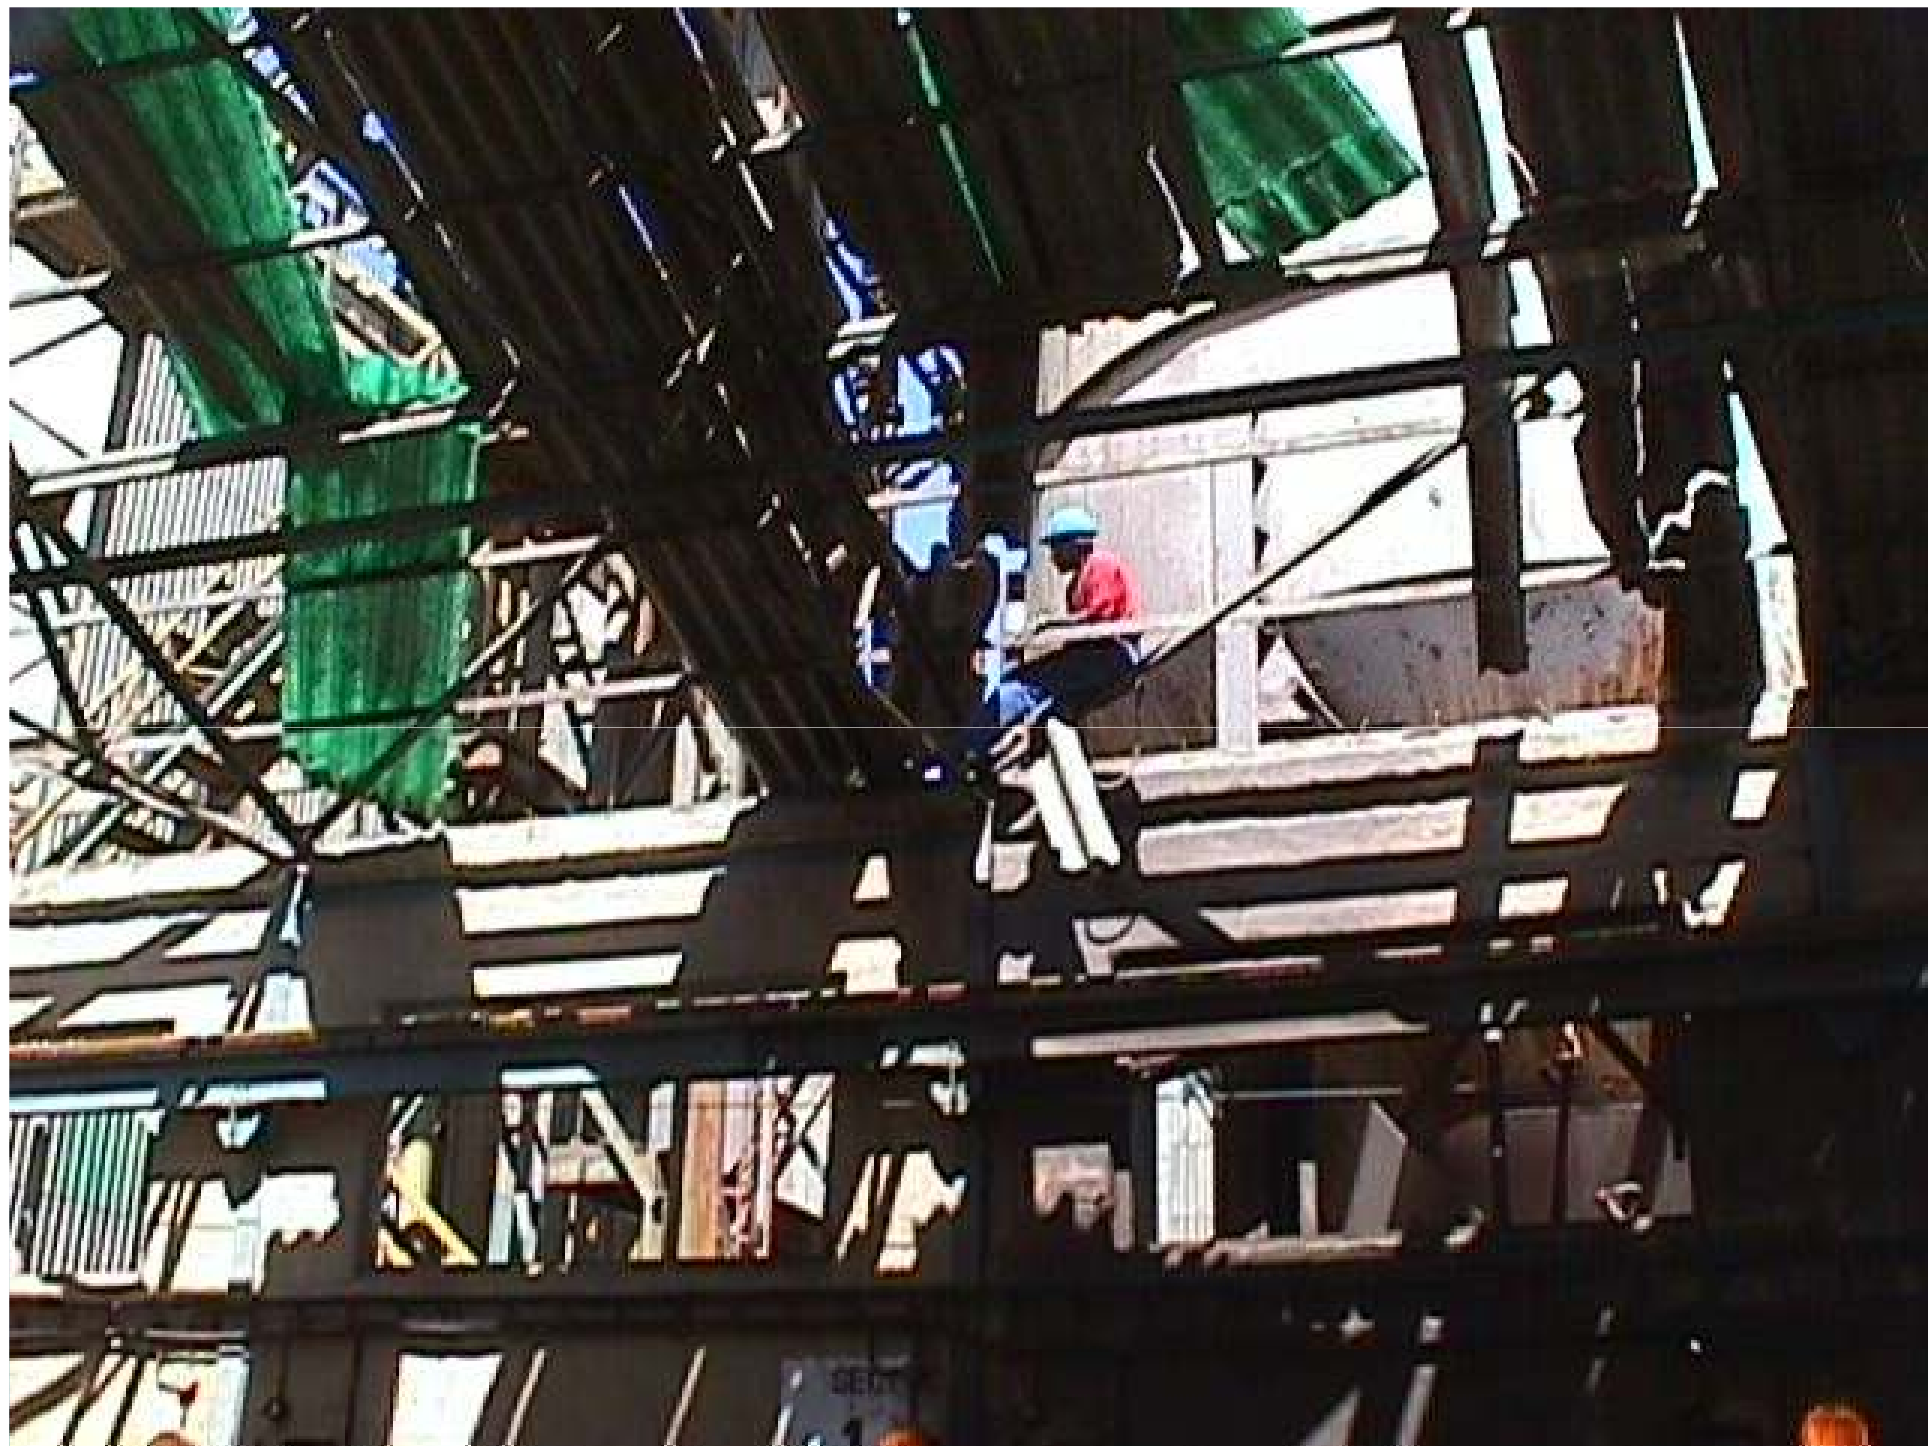
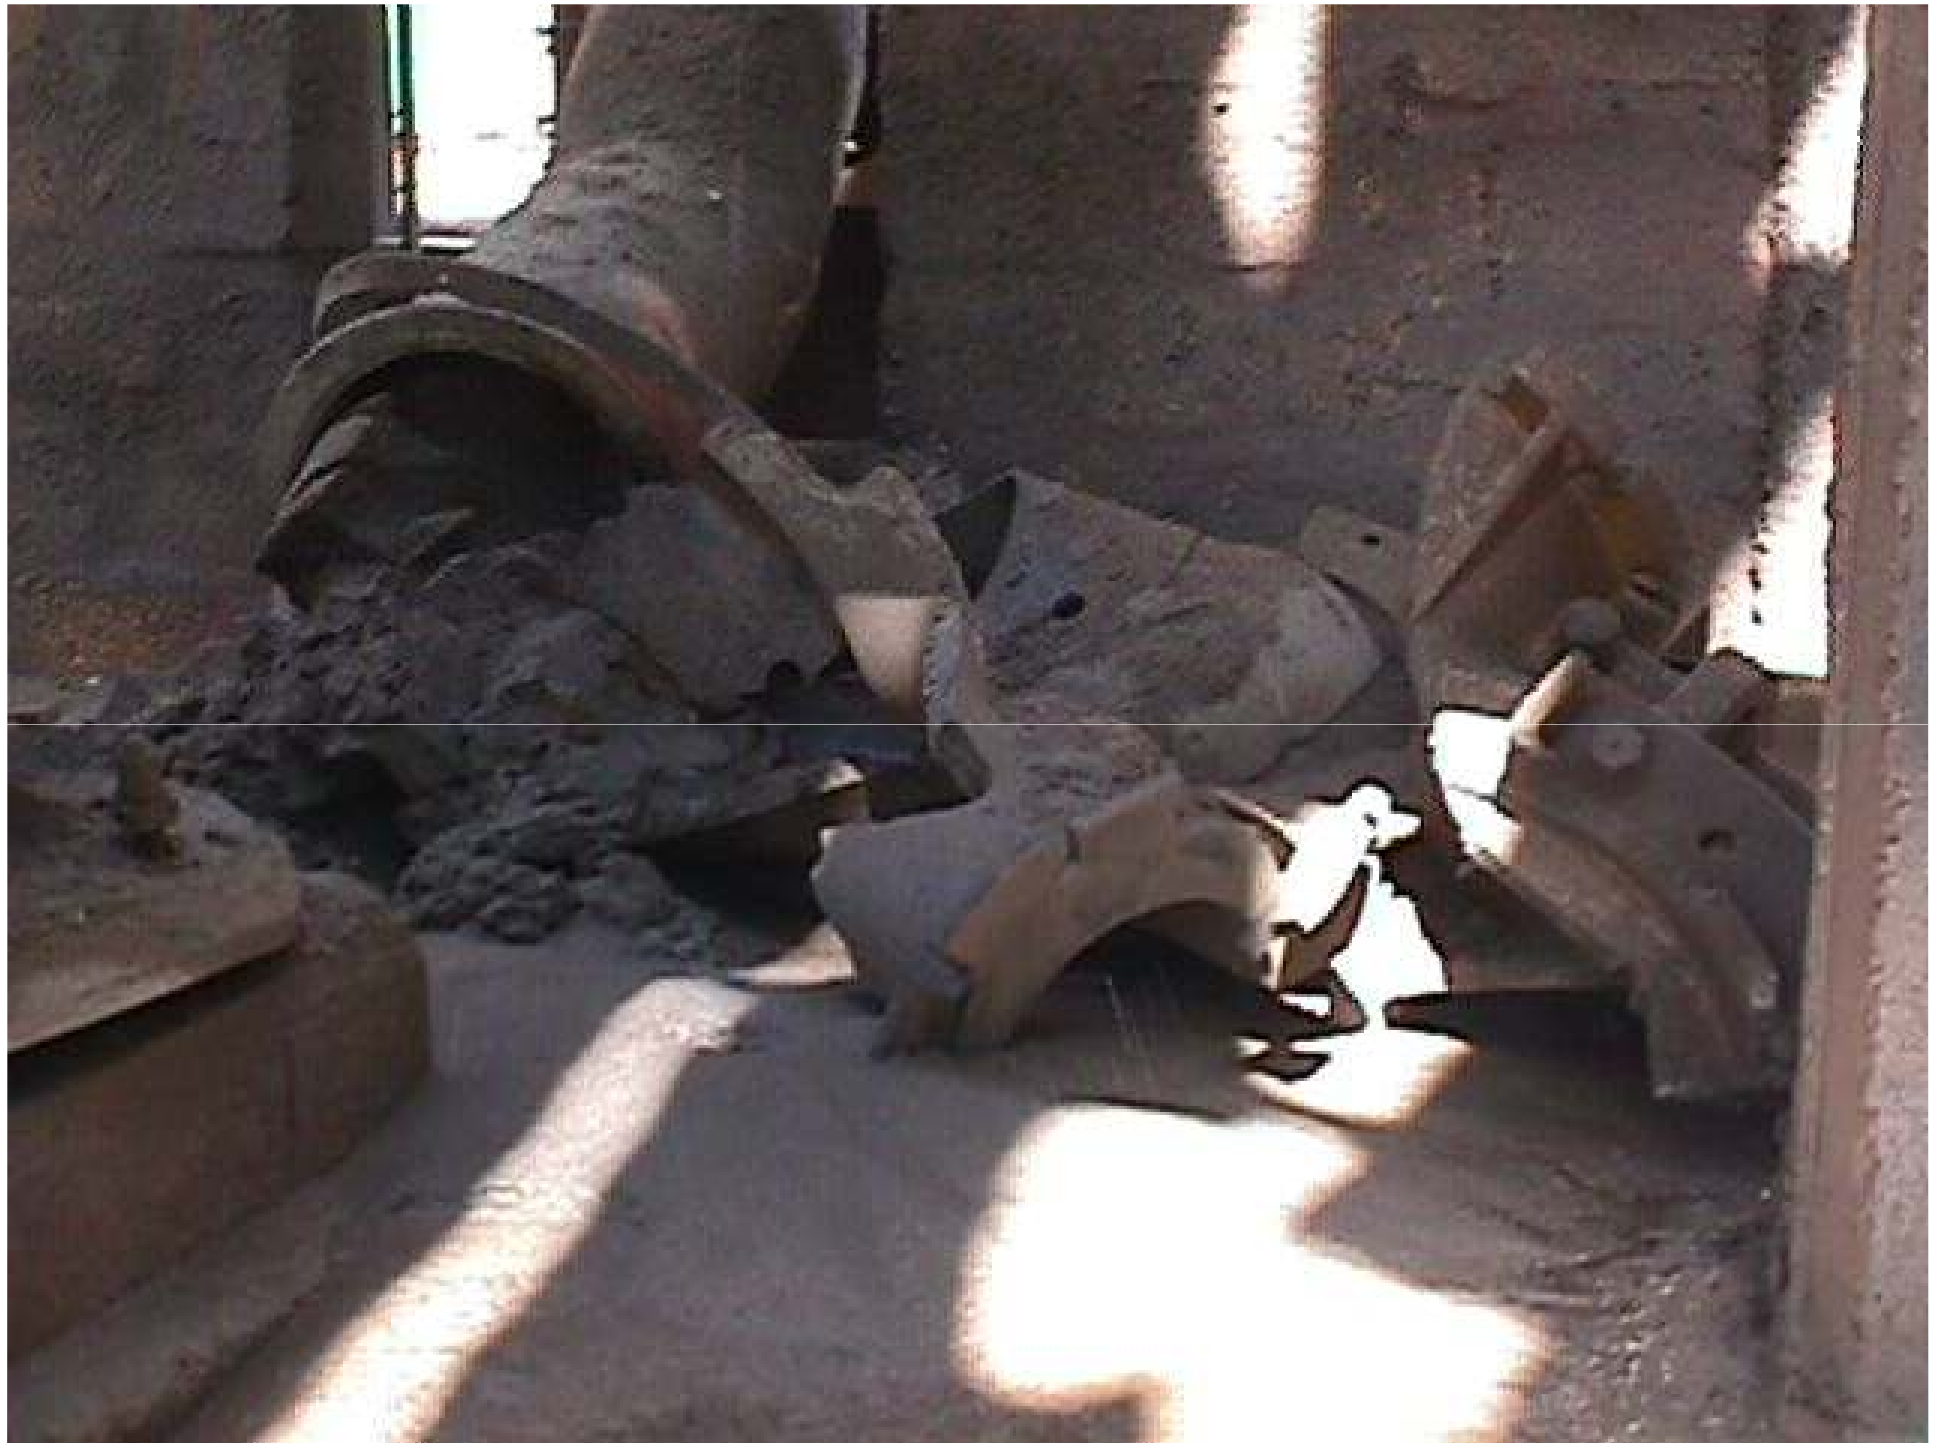
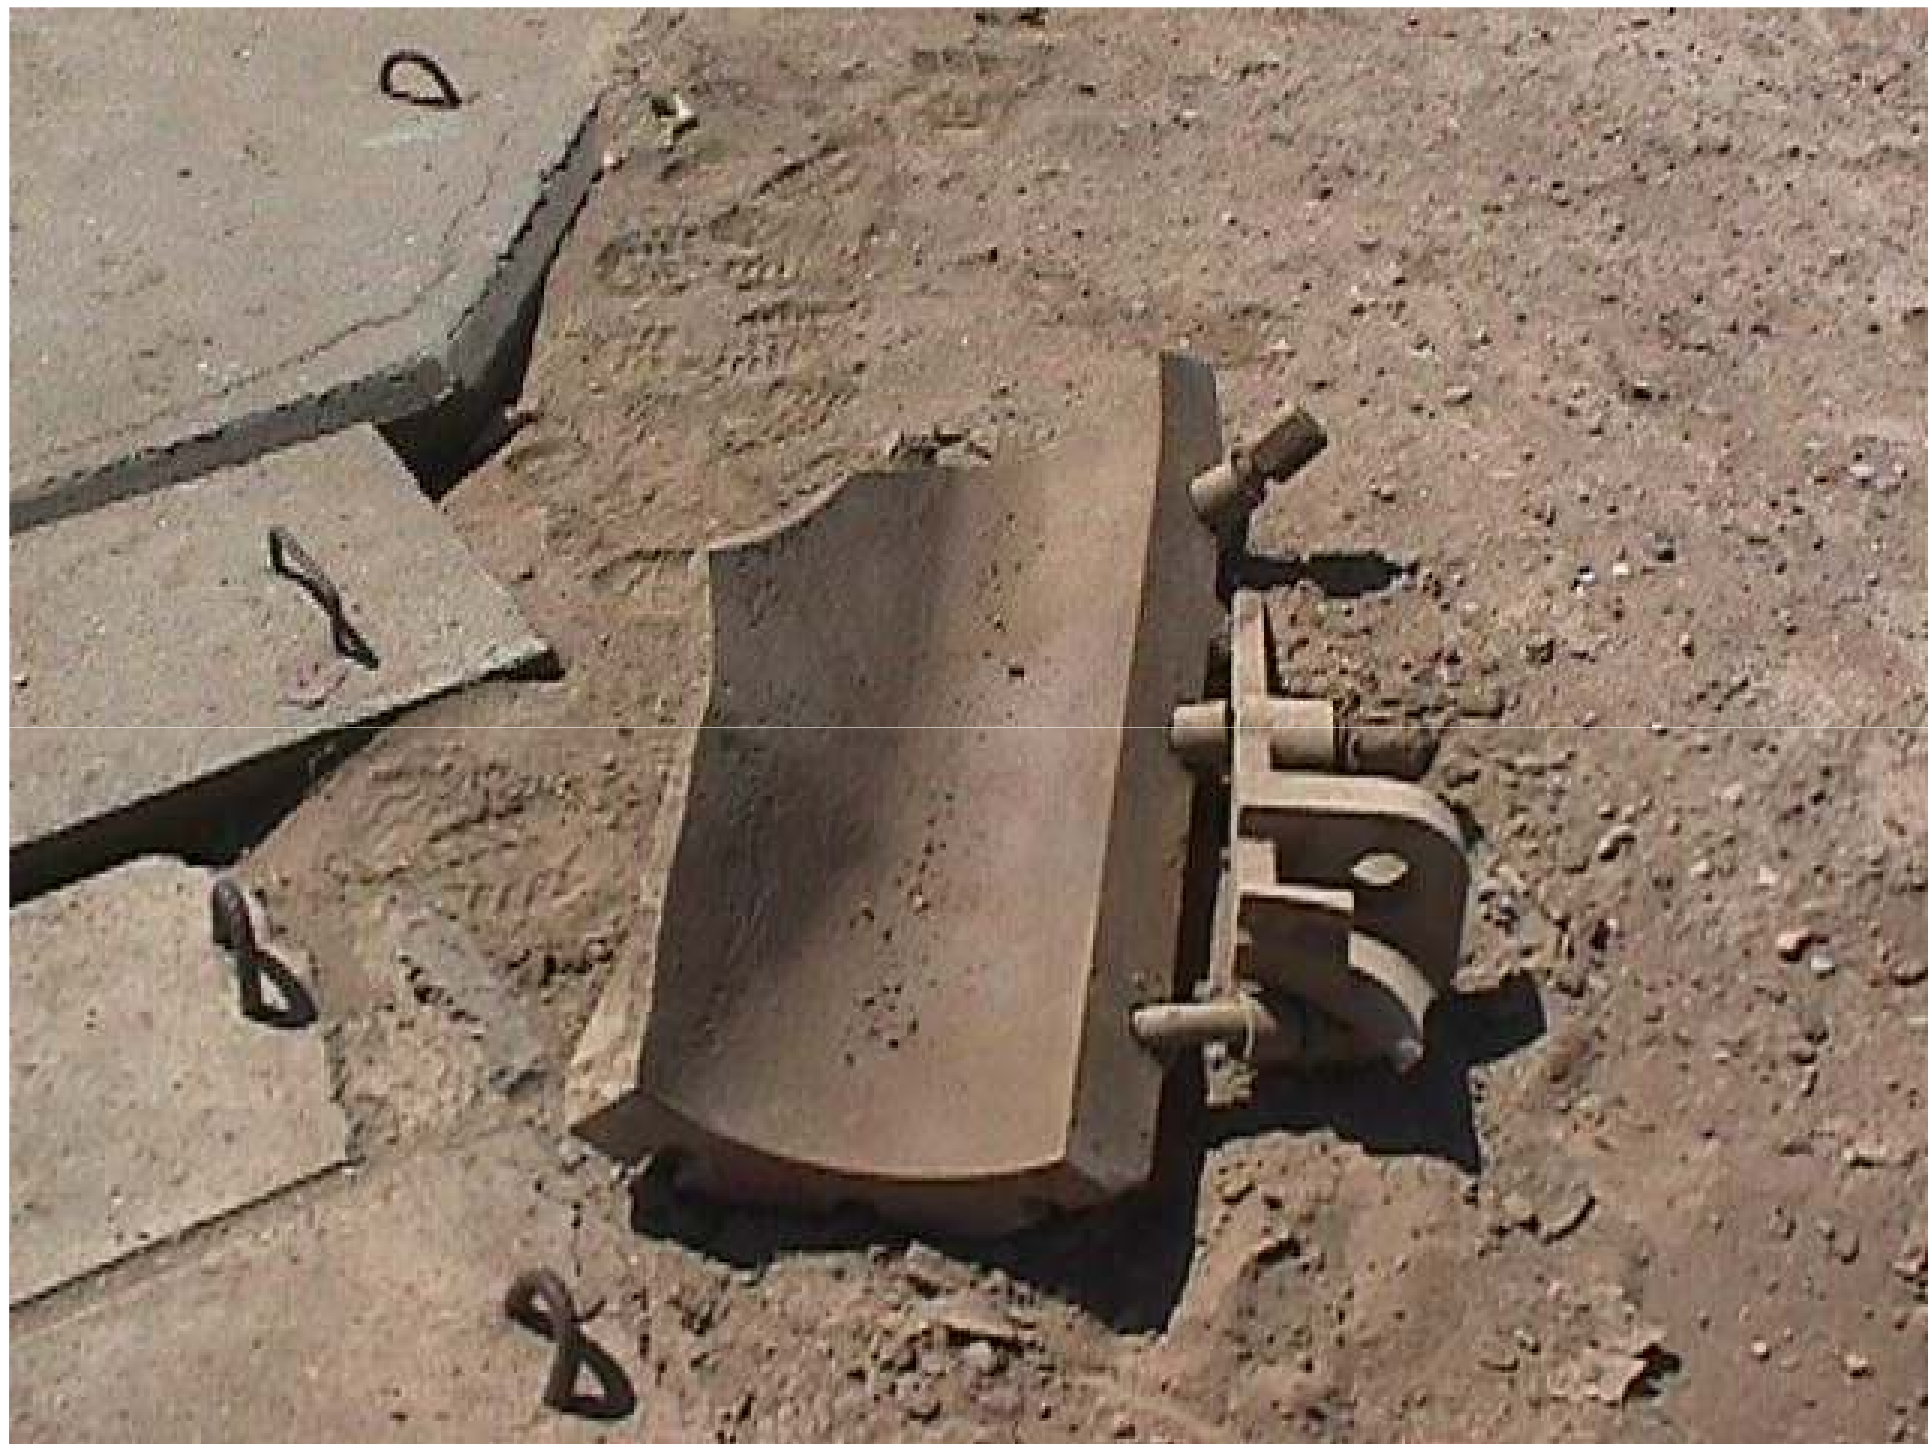
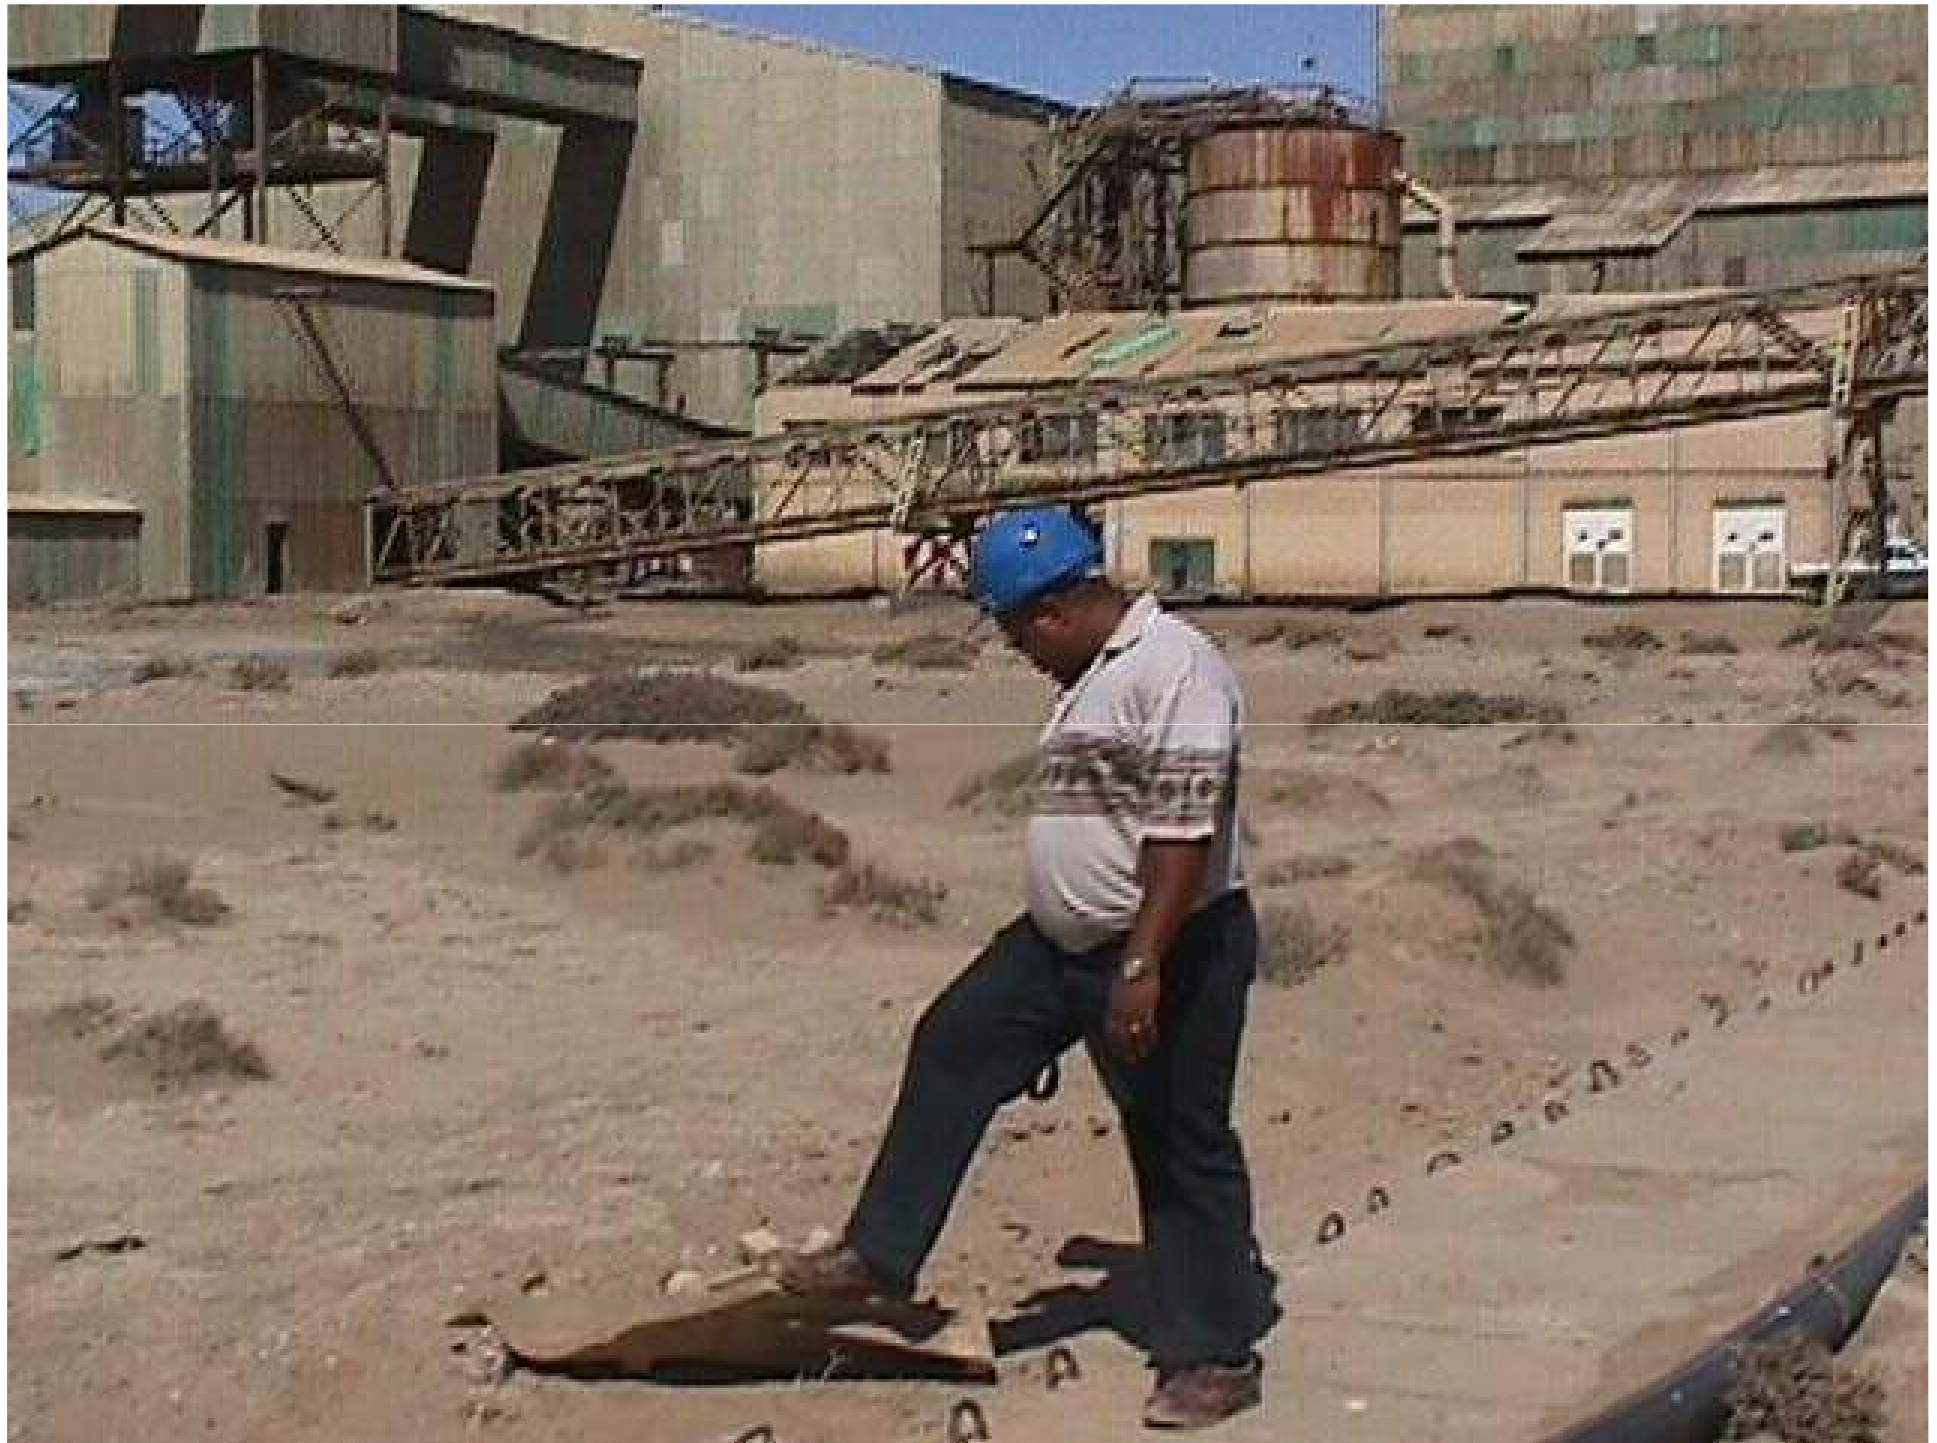
8. North 2 Gold Plant - November 2001.
Cyanide transfer pump.
9. West Float & Acid Plant - February 2001.
Calcine water pump.
10. North 1 Gold Plant – January 2003.
Carbon transfer pump.
11. Residue transfer pump at Namdeb, Namibia
in March 1999

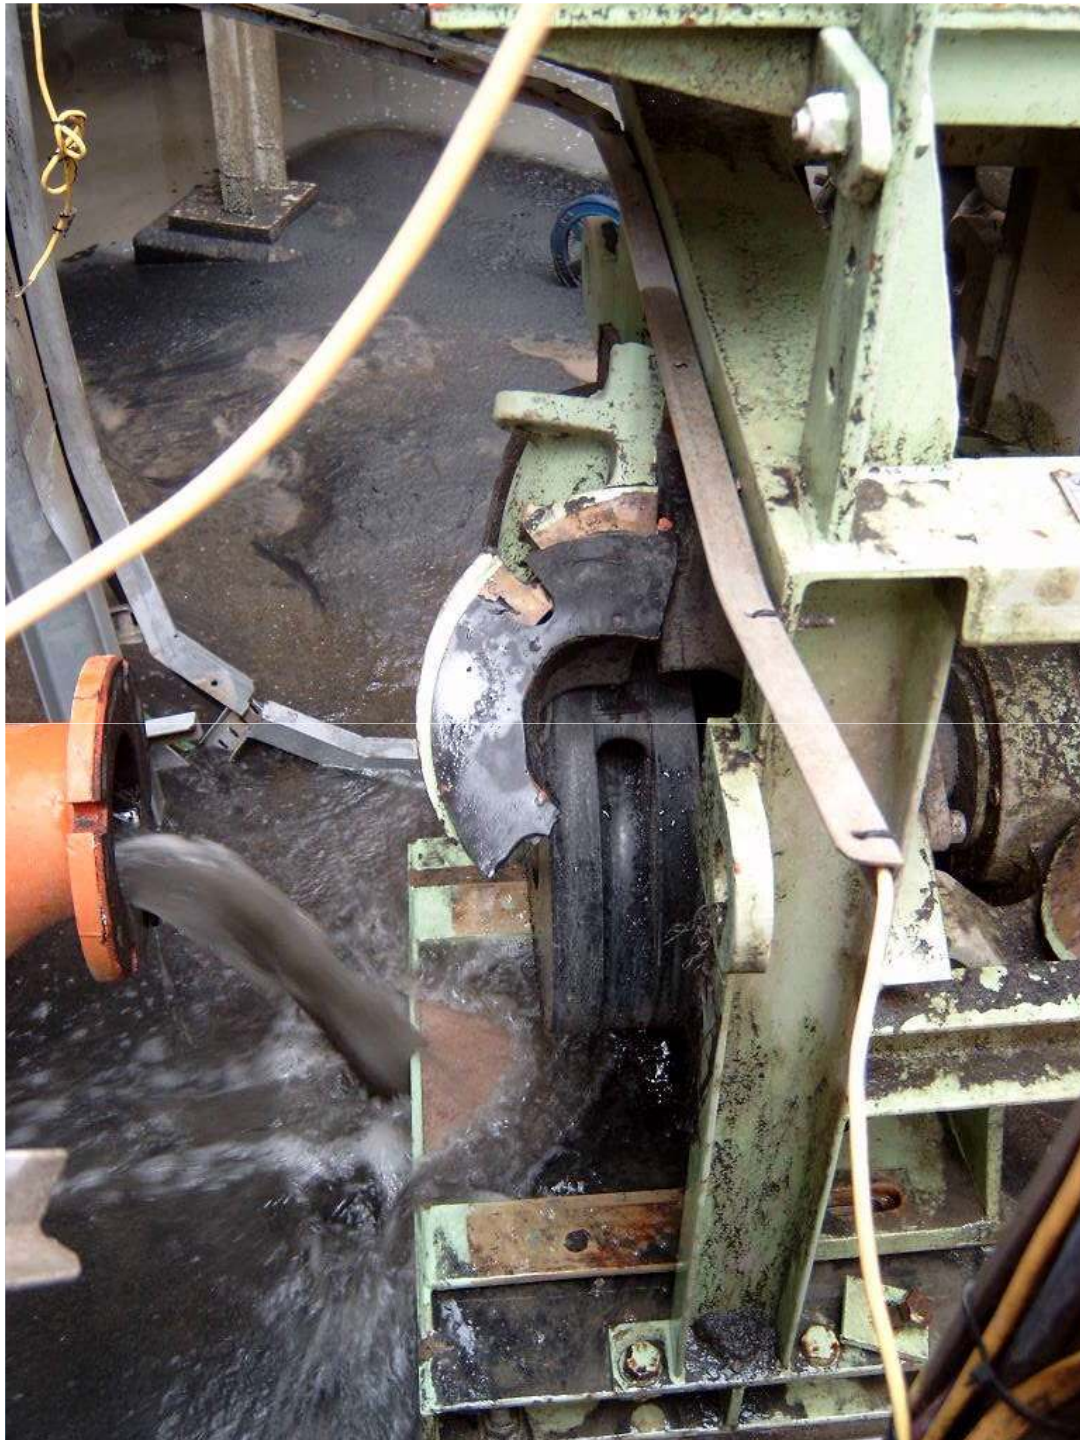
Modikwa UG2 transfer
pump explosion on
25 October 2003 resulting
in operator loosing three toes.
