Centrifugal Pump Explosions

“Rise of the machines”

Brian P. O’Connor

16 March 2006

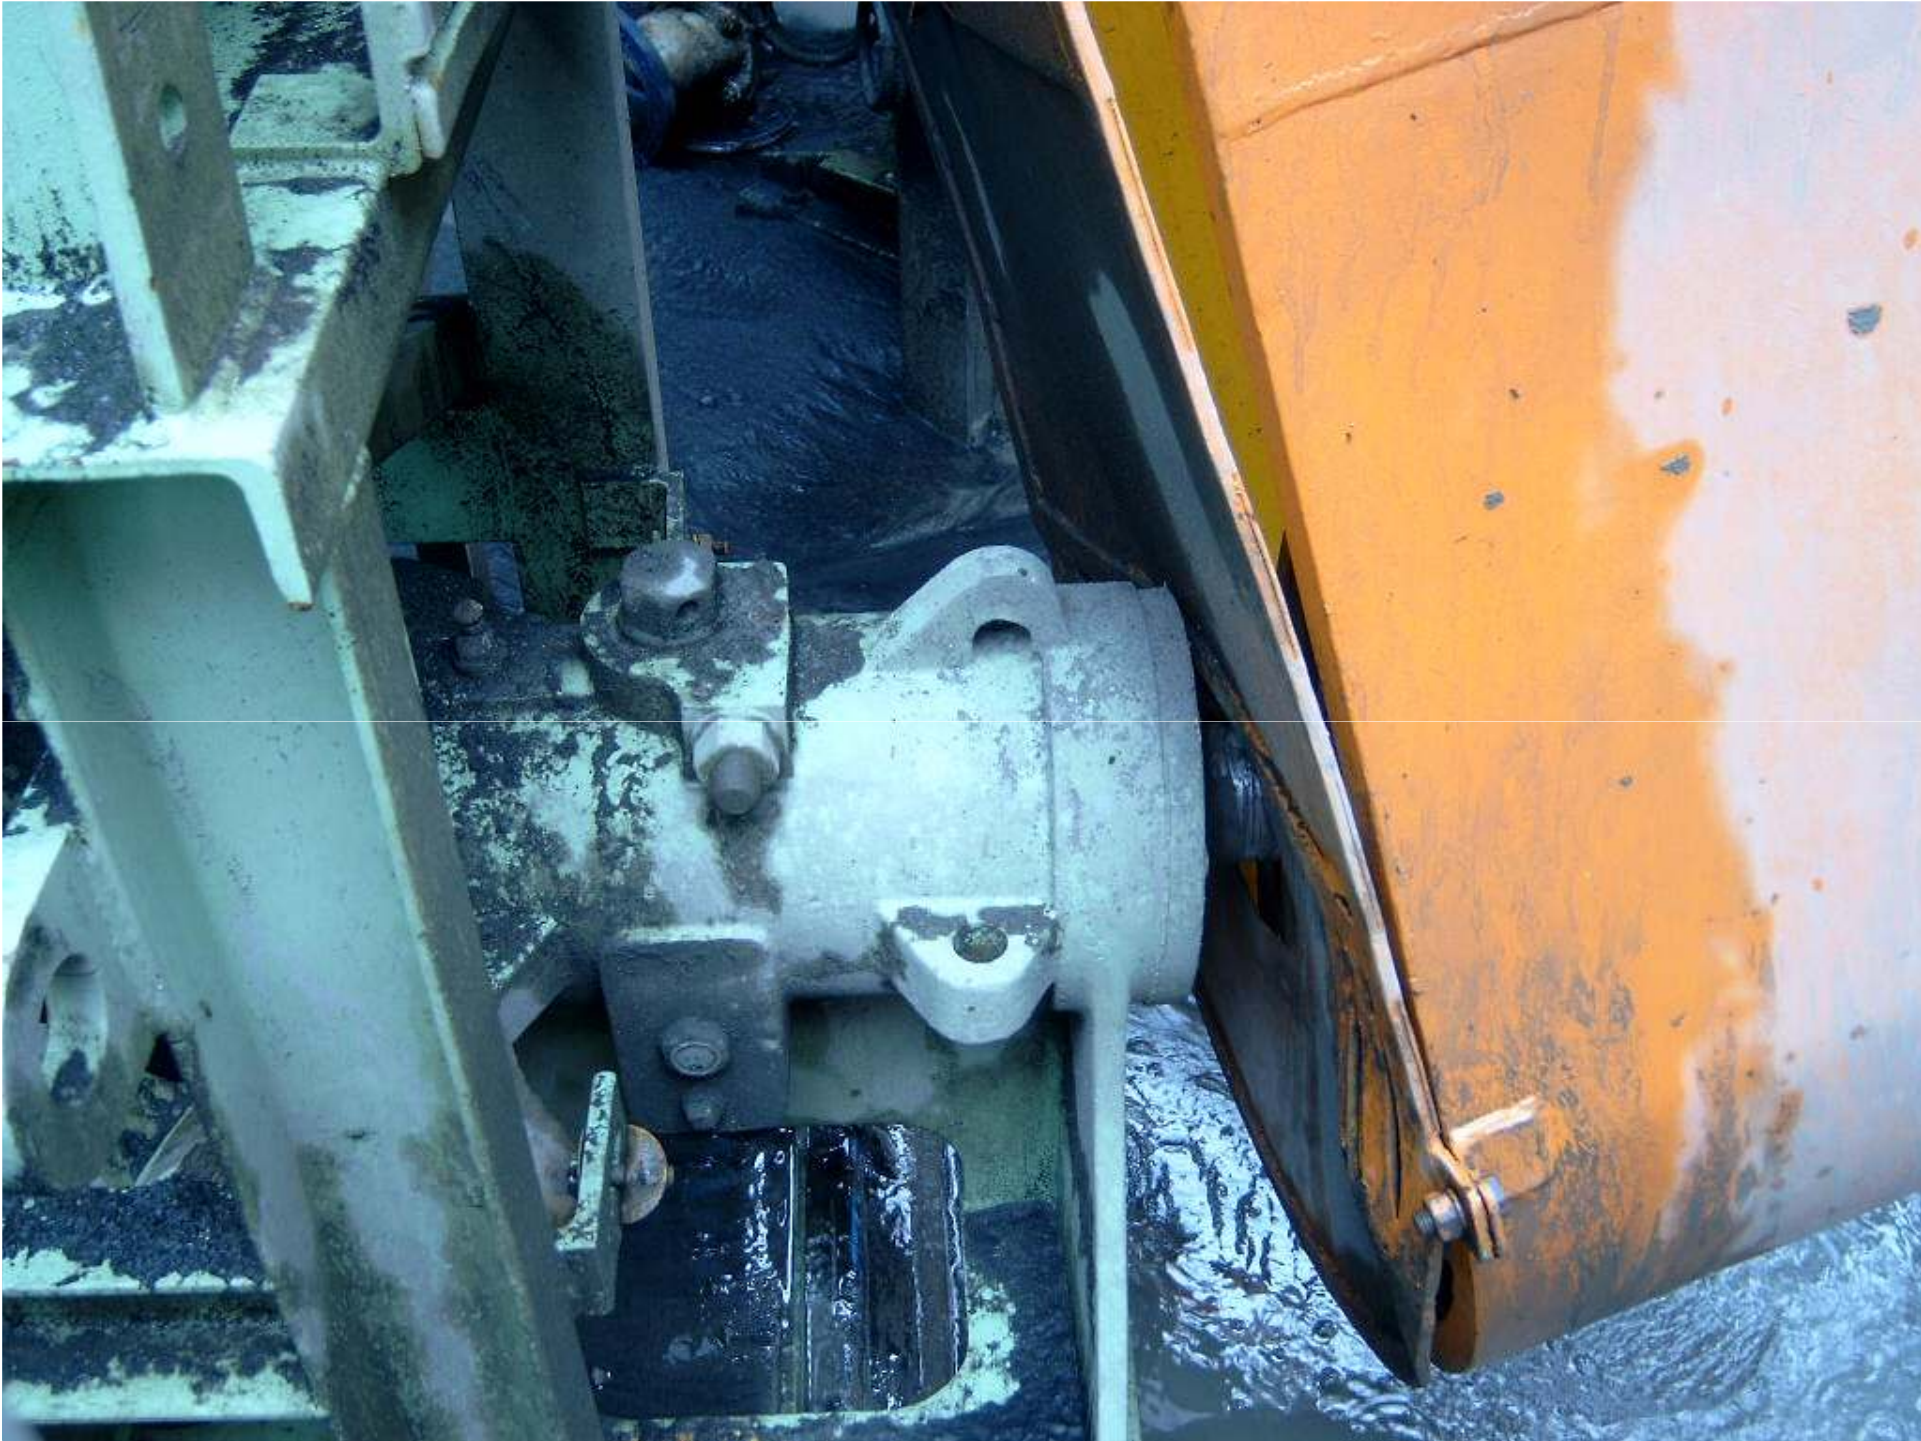
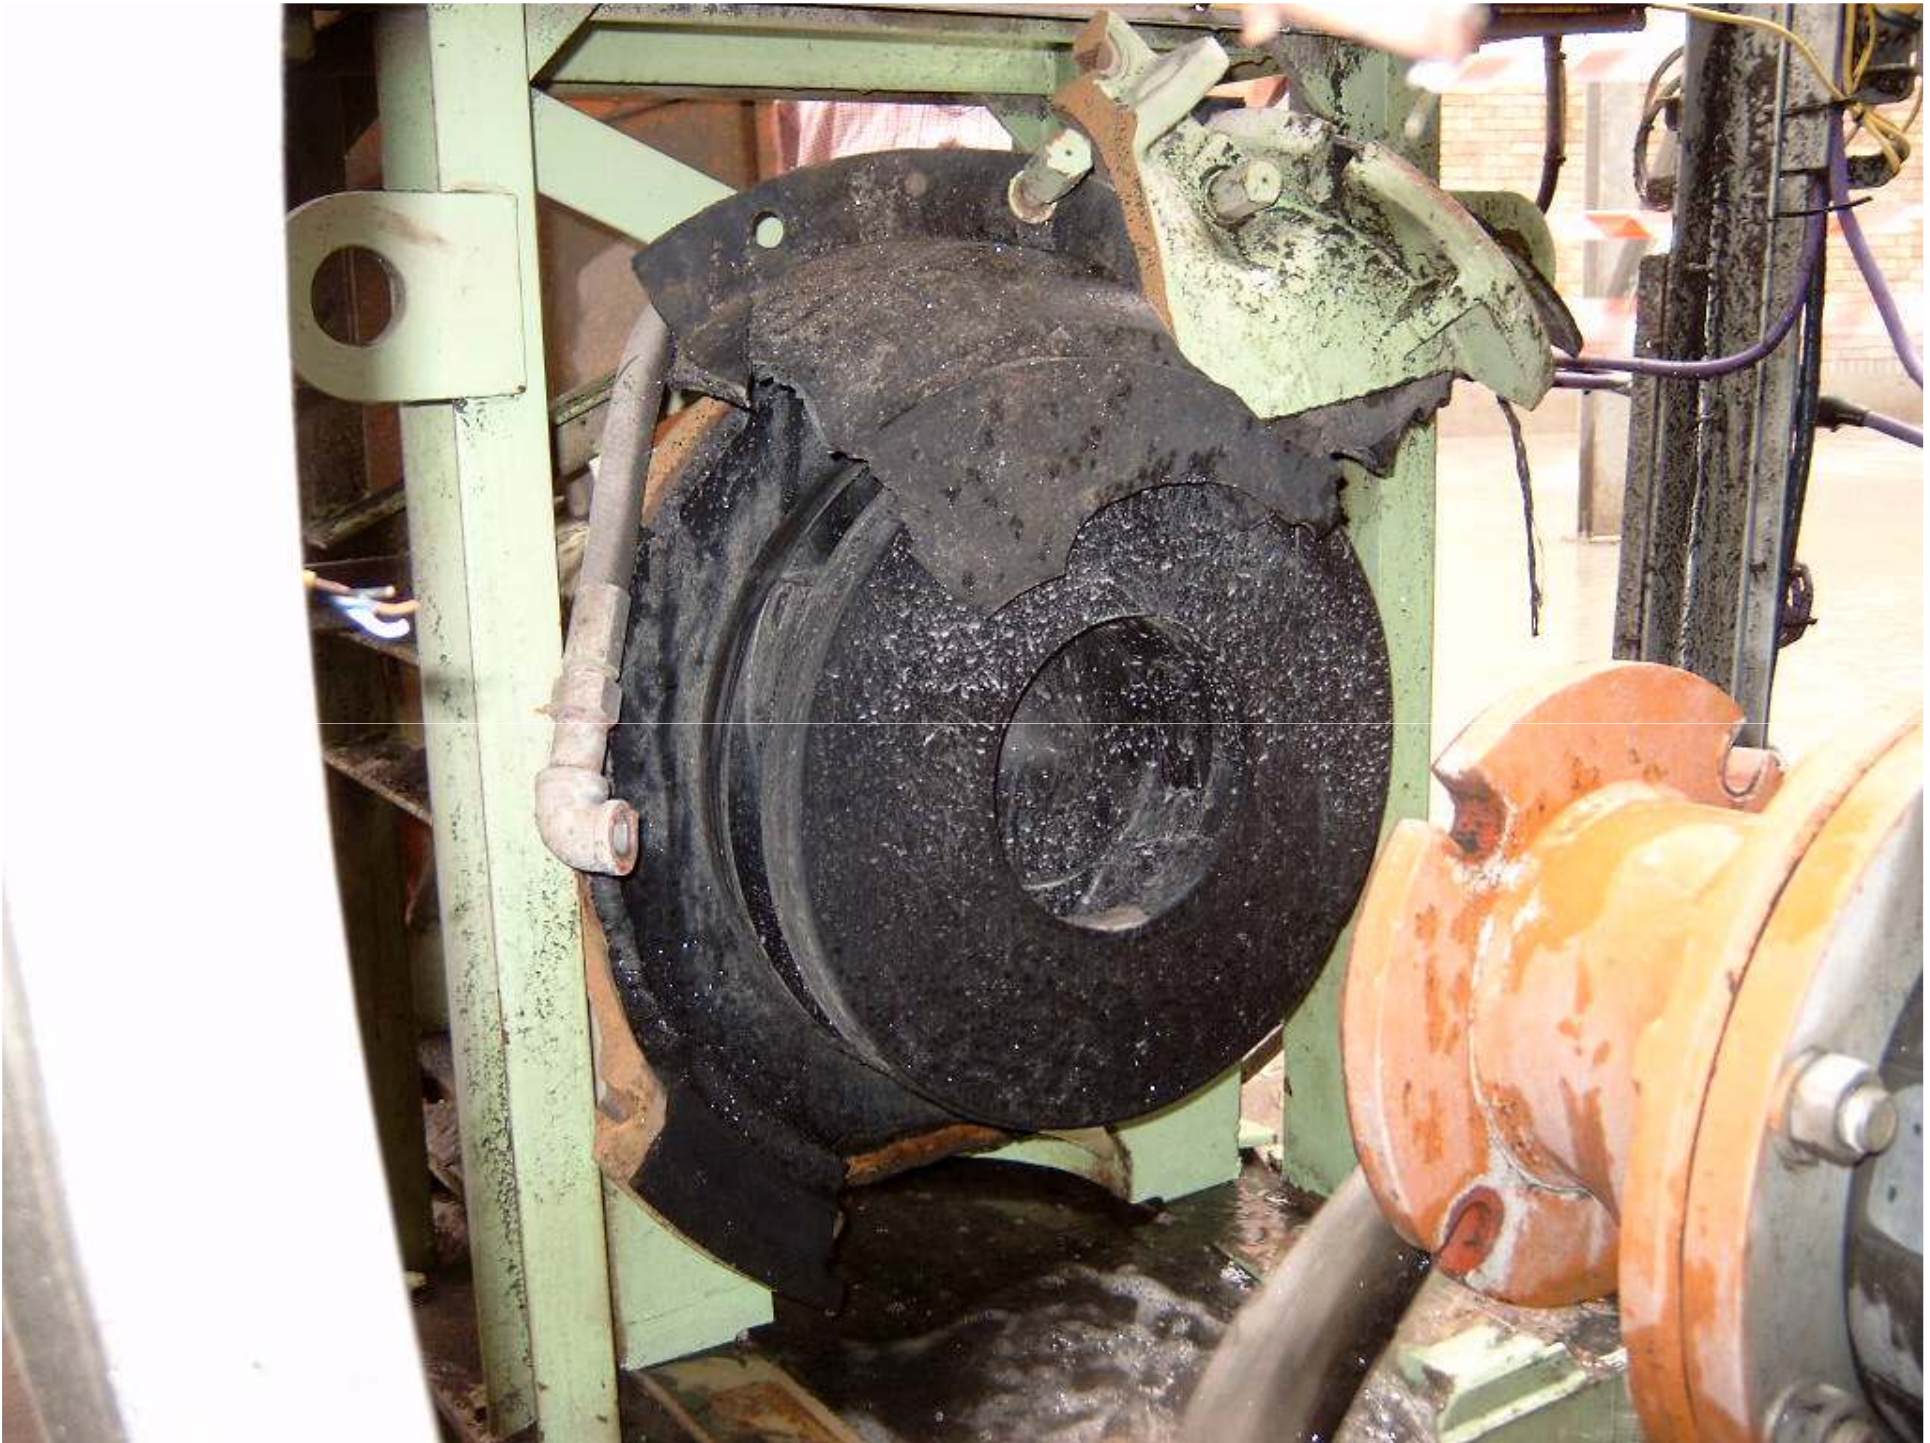
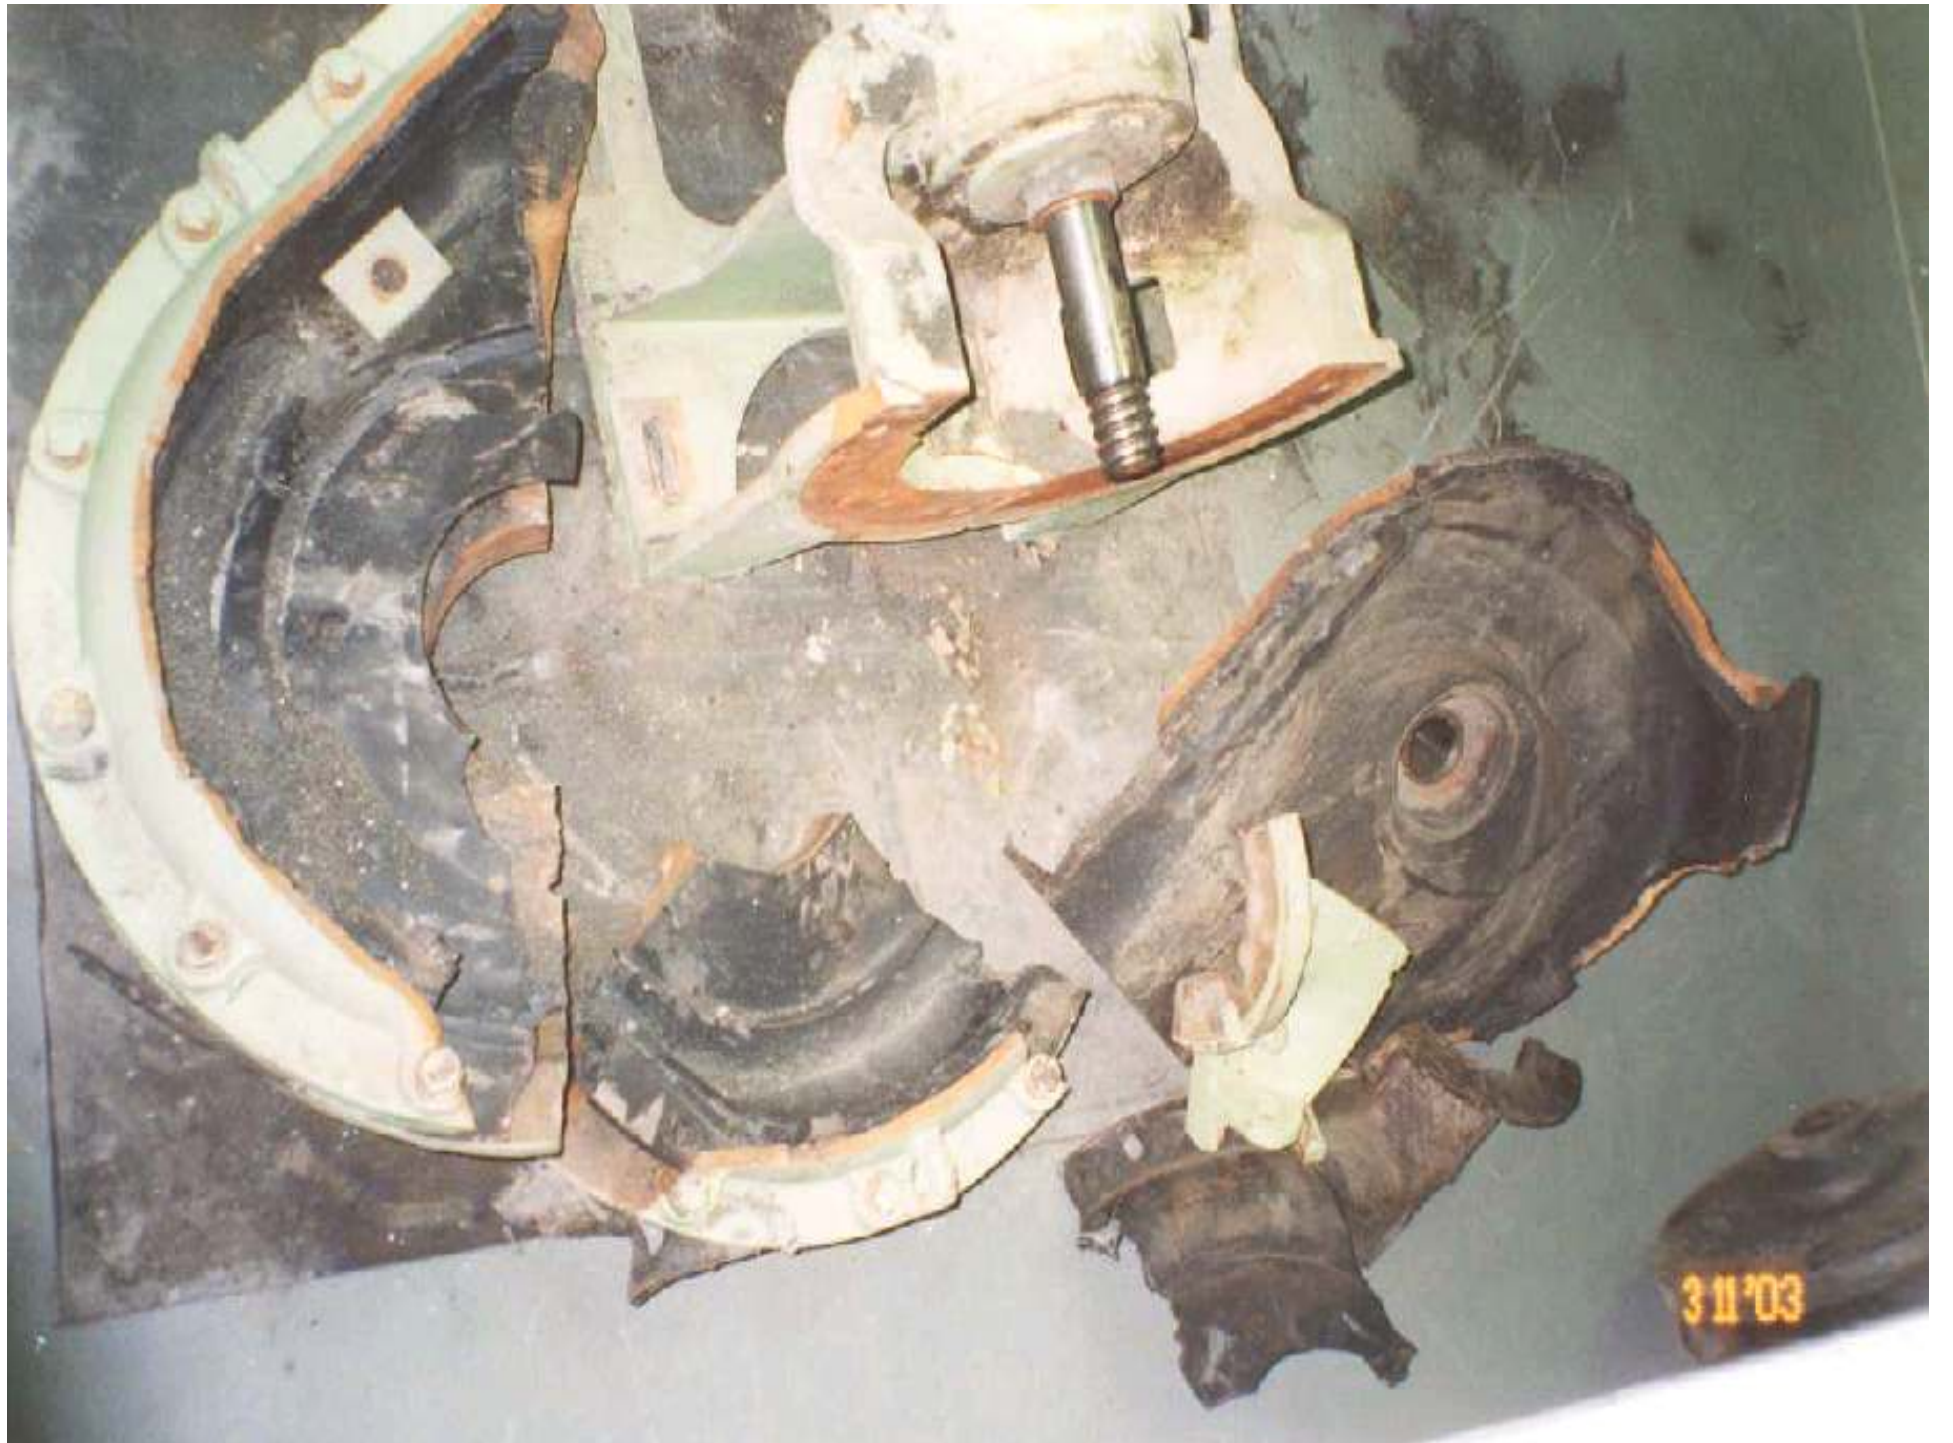
Modikwa UG2 transfer
pump explosion on
25 October 2003 resulting
in operator loosing three toes.

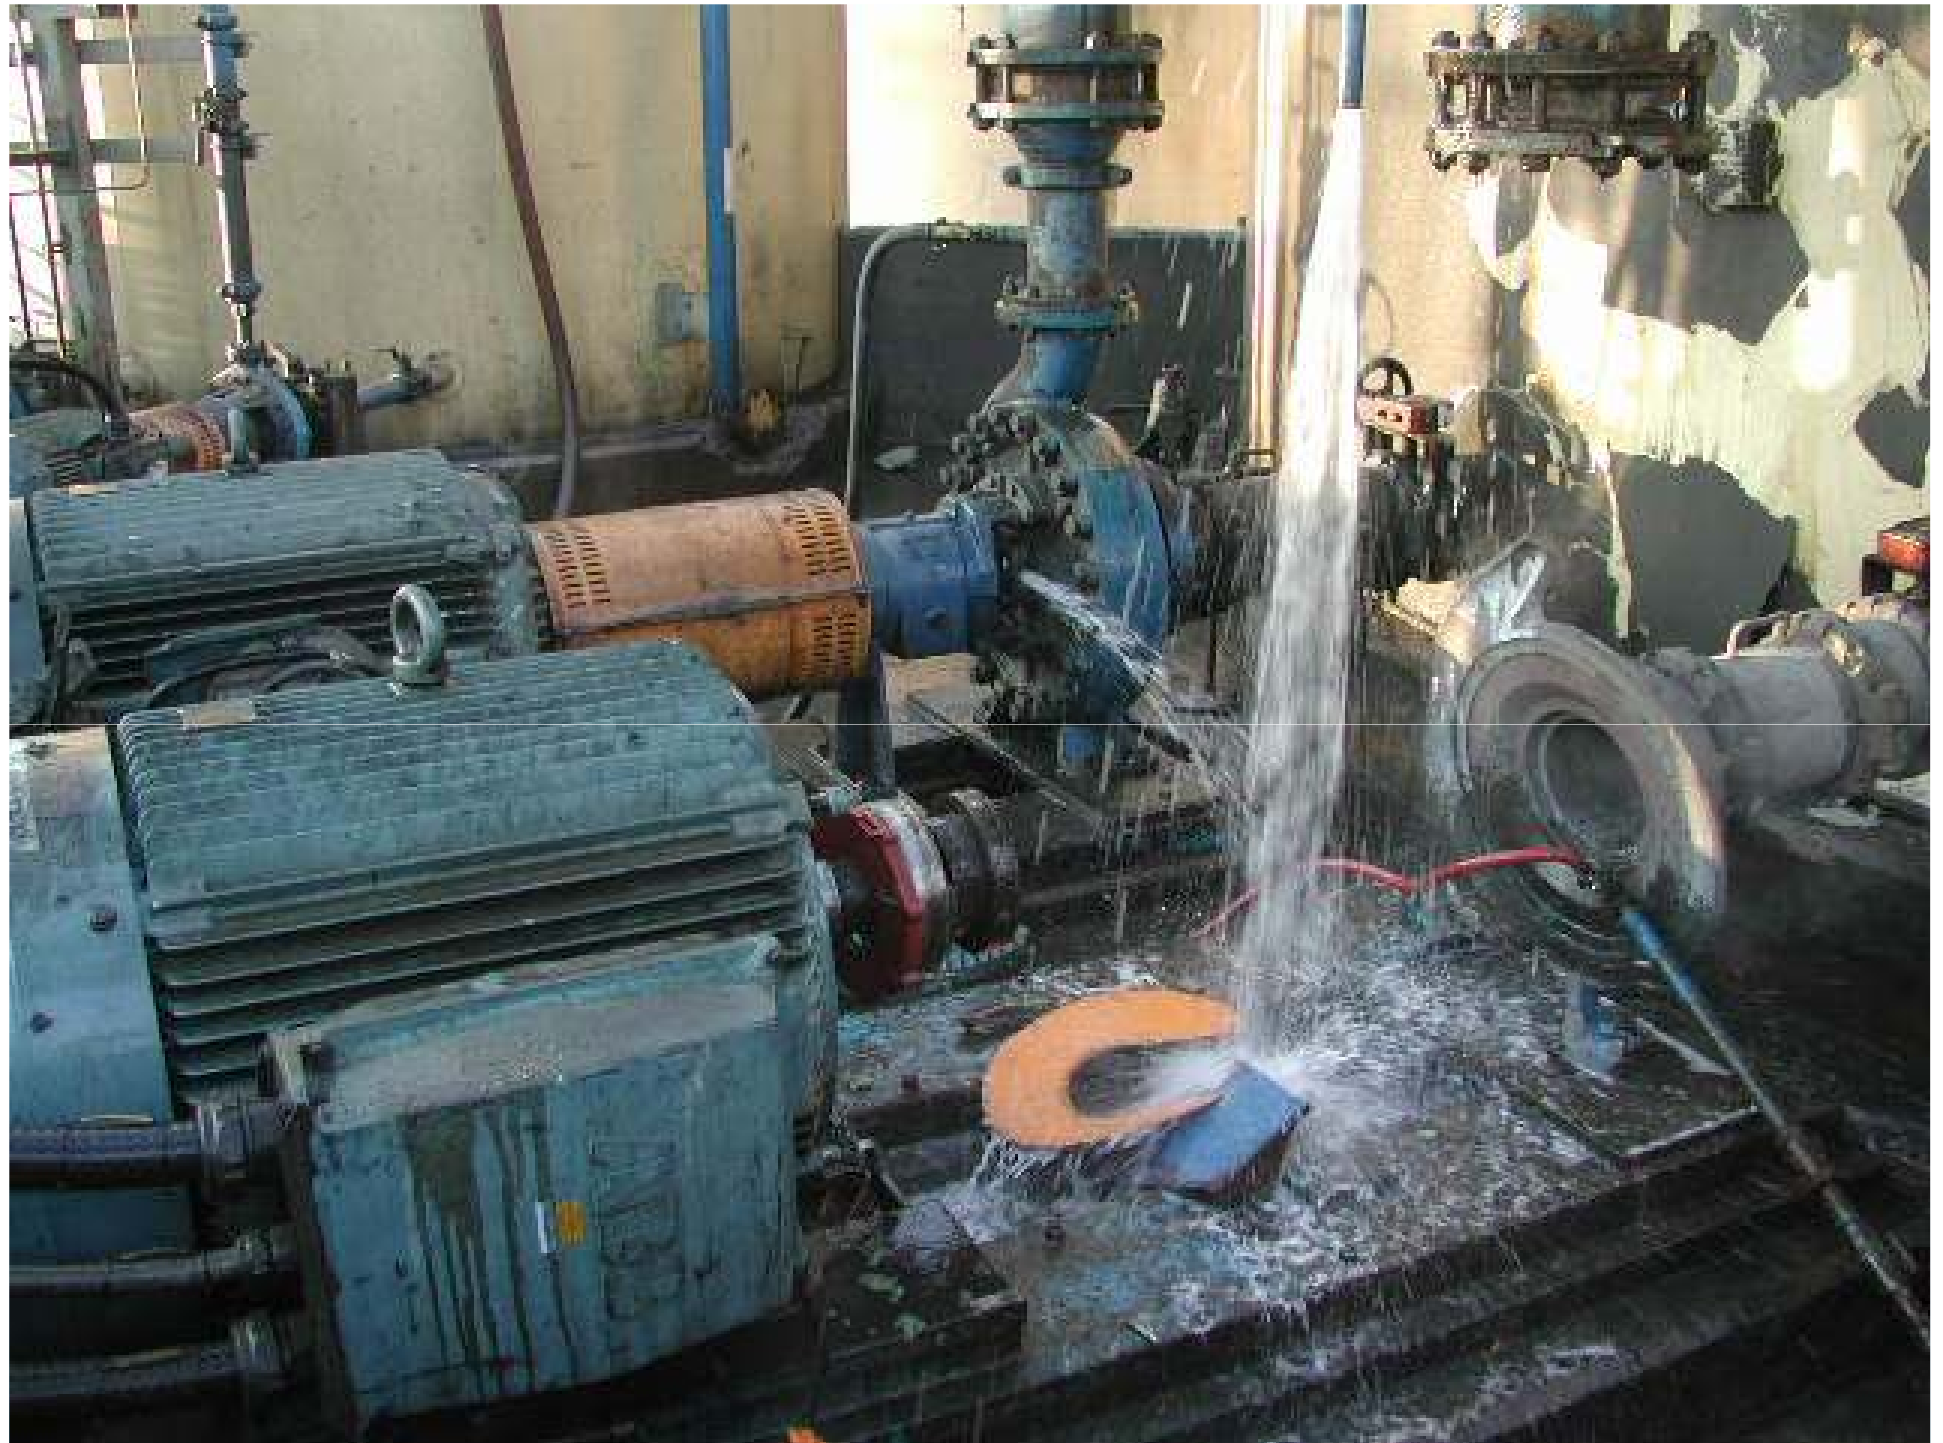
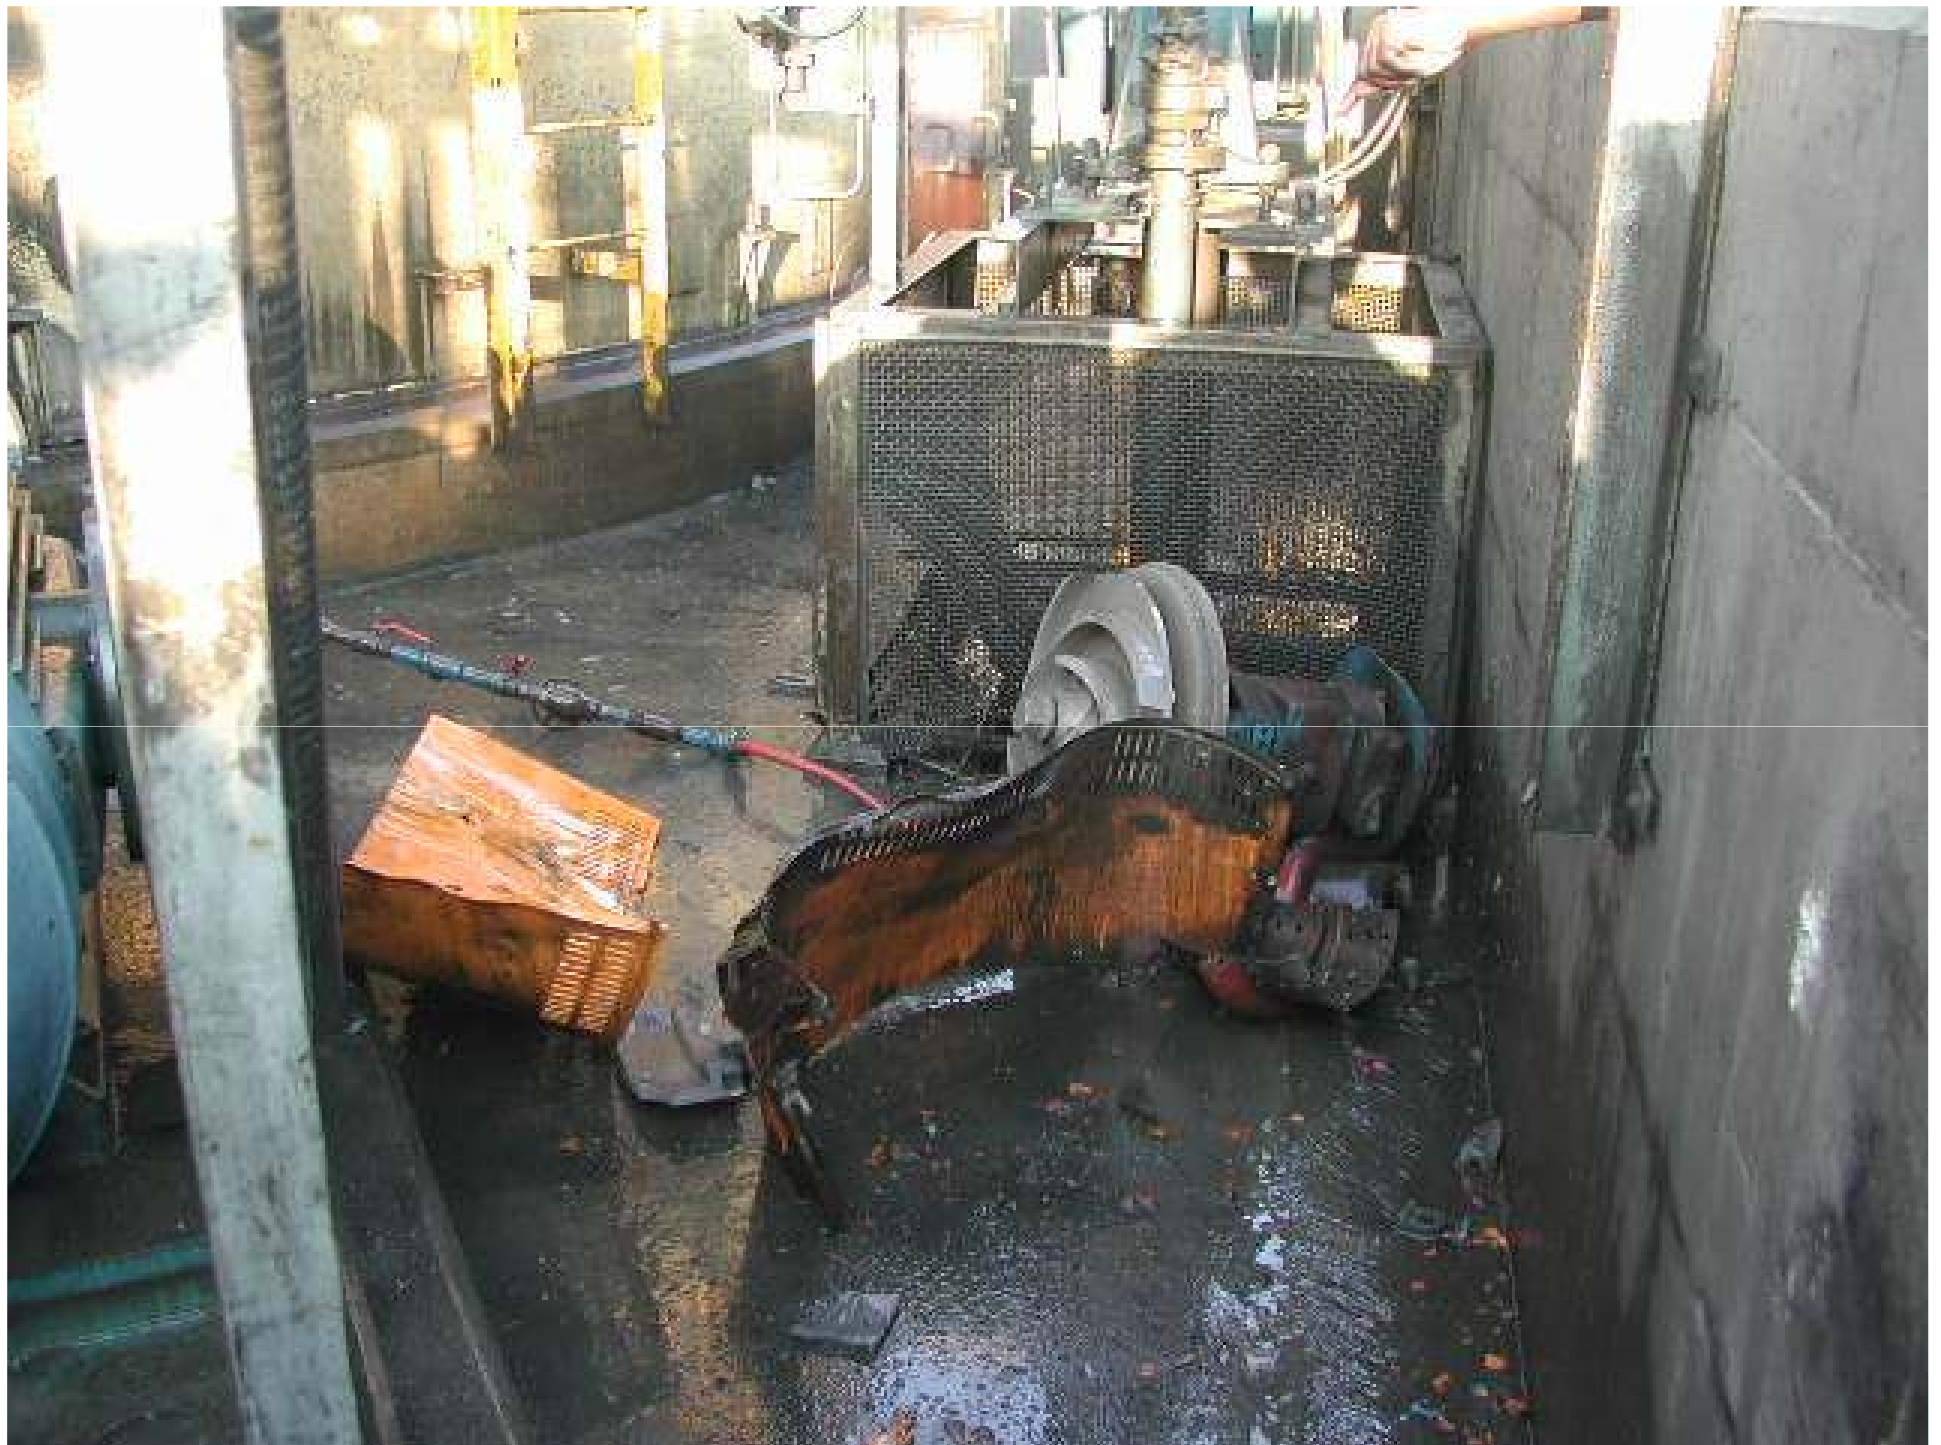
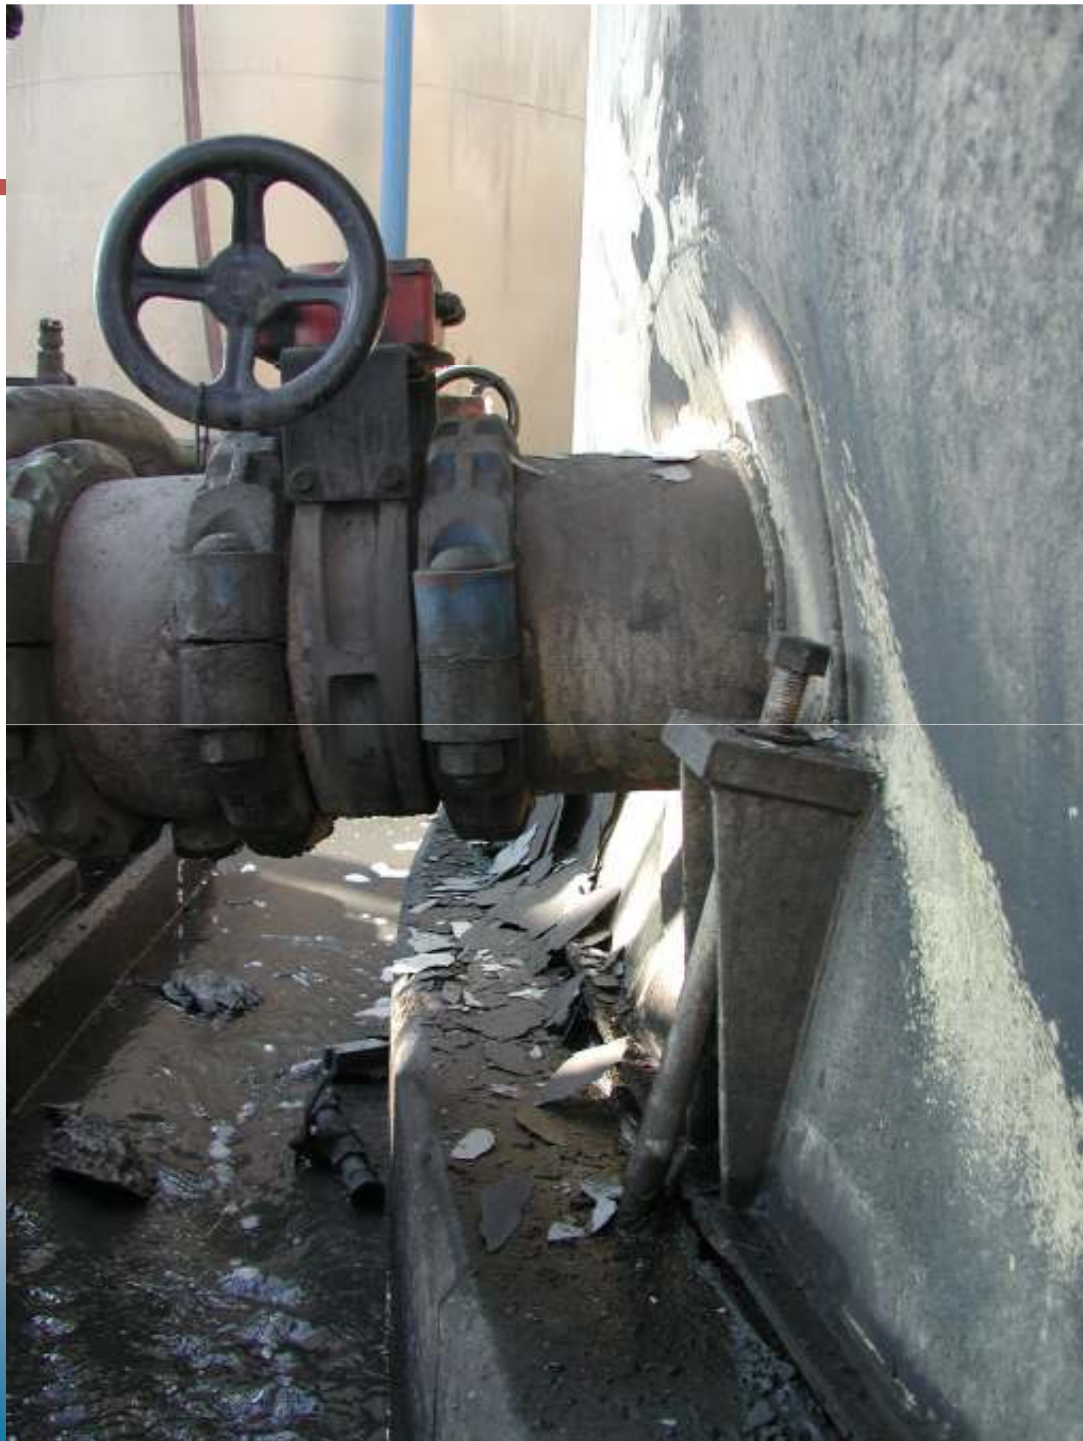
13. Bulyannulu Gold Mine in Tanzania – July 2004

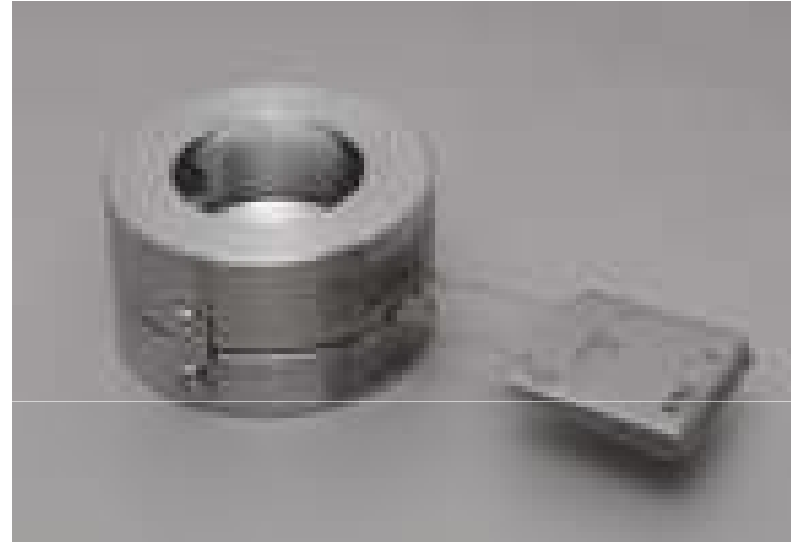
Disc holder
R1 400

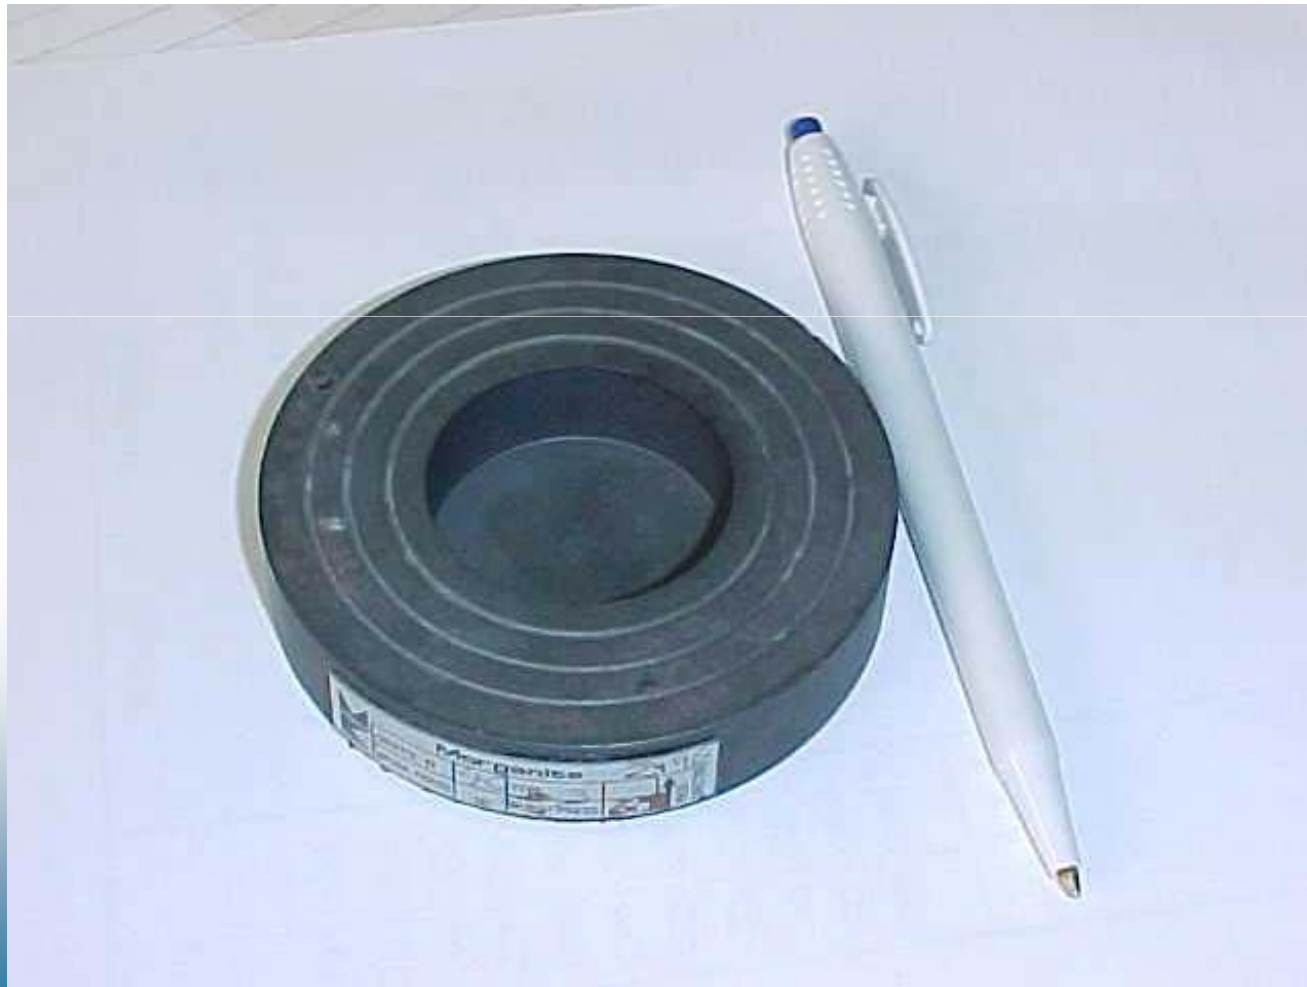
Graphite bursting discs R230

- Initial problems were experienced due to handling and installation.
- Standard disc was 6 bar rating.
- Discs that were scratched failed below their rating.
- Rubber gaskets were placed between flanges to avoid damage.
- Pumps that were fed from a higher pressure source than 3 bar were fitted with 8 bar discs.

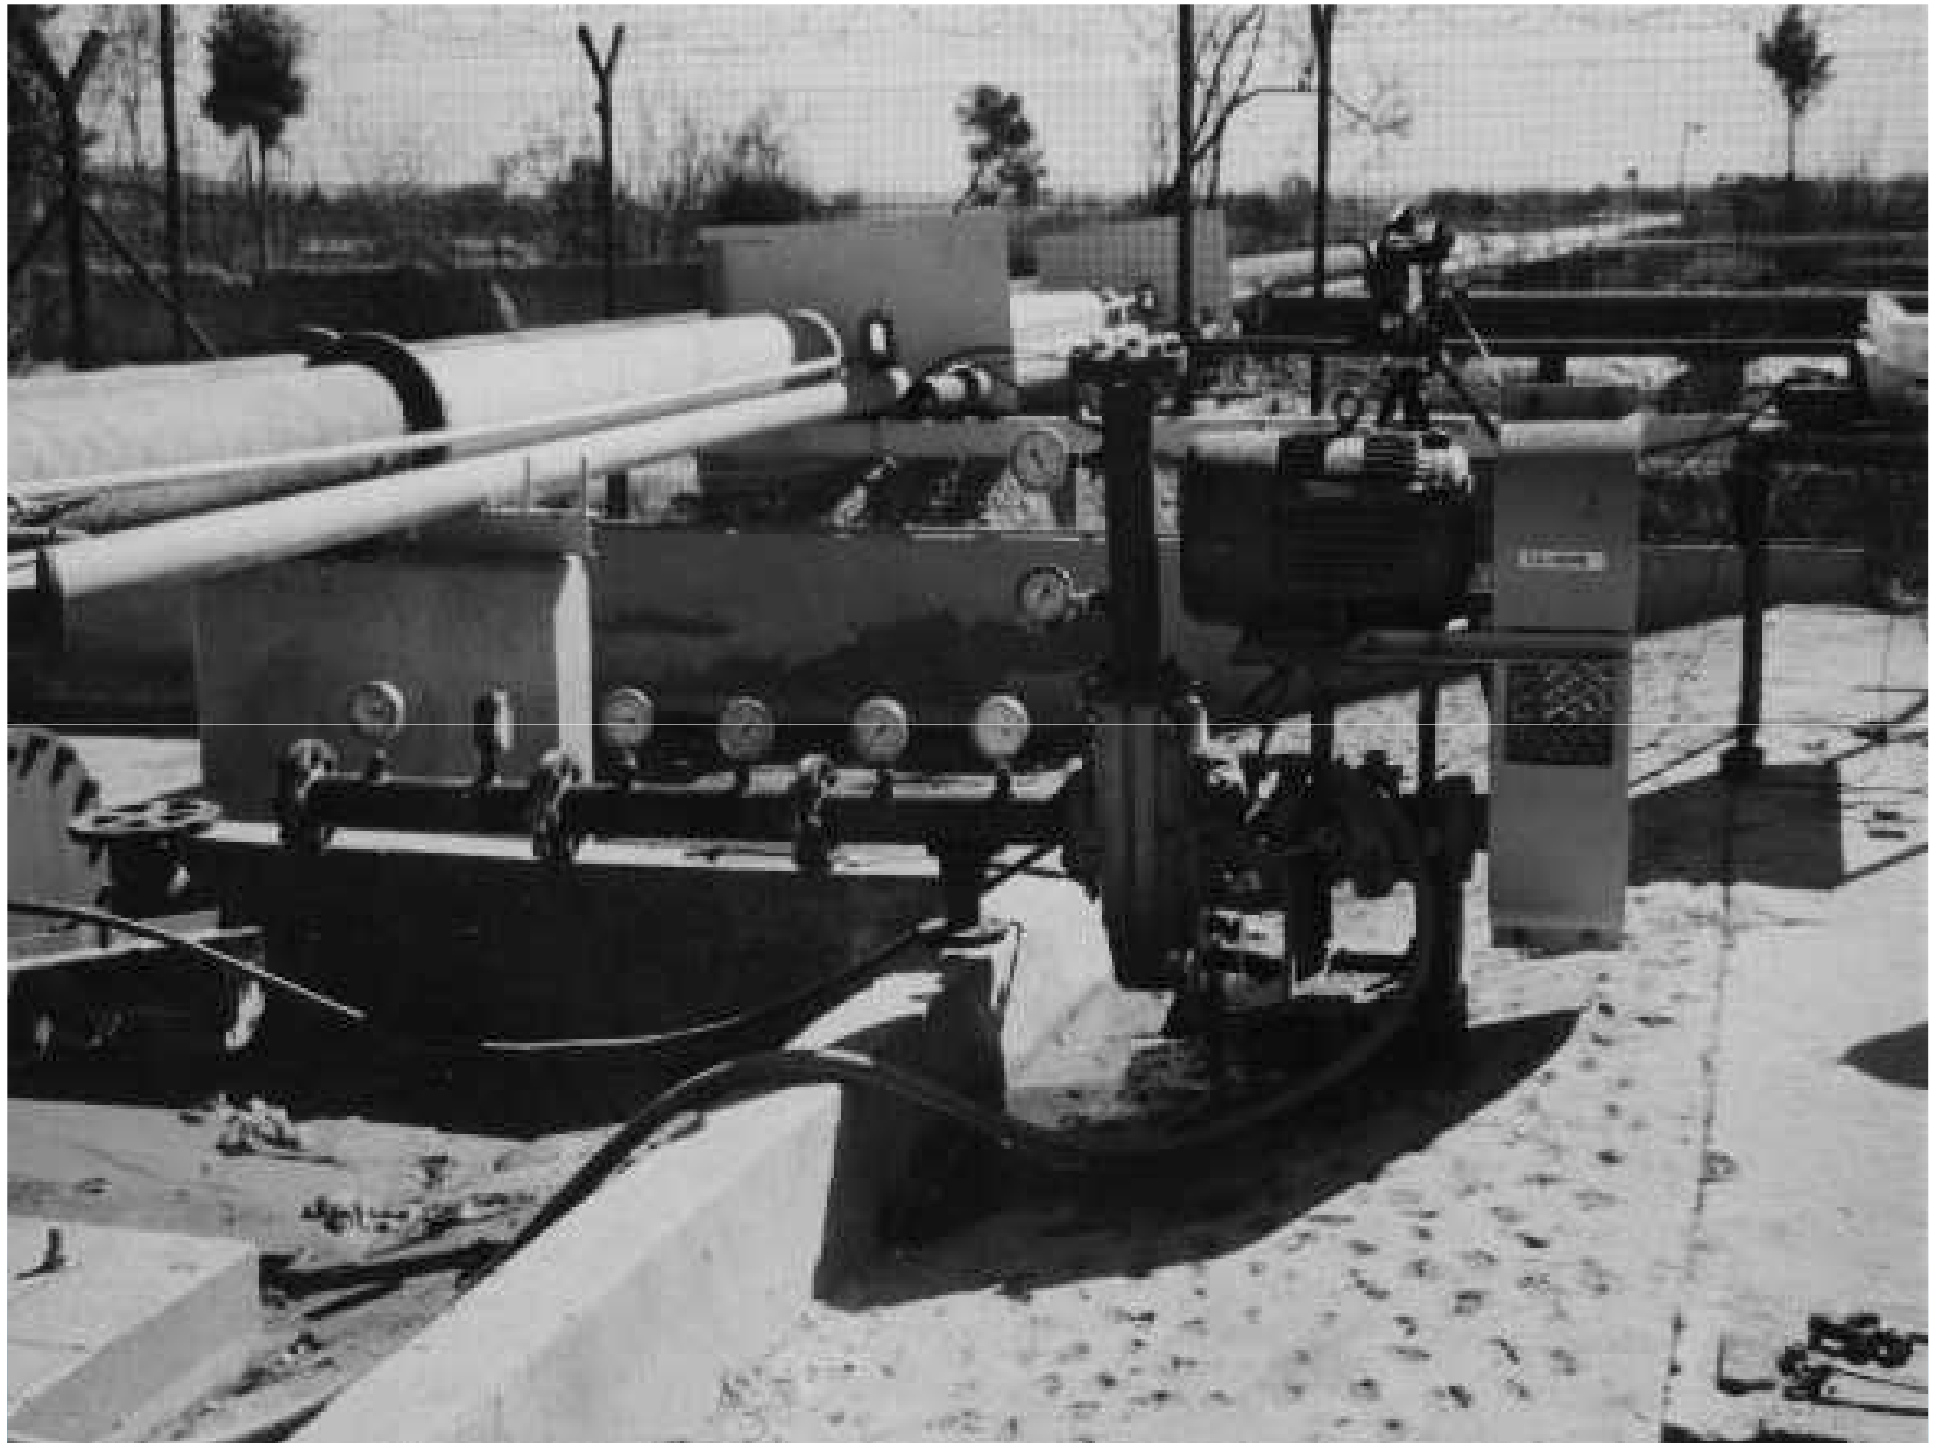
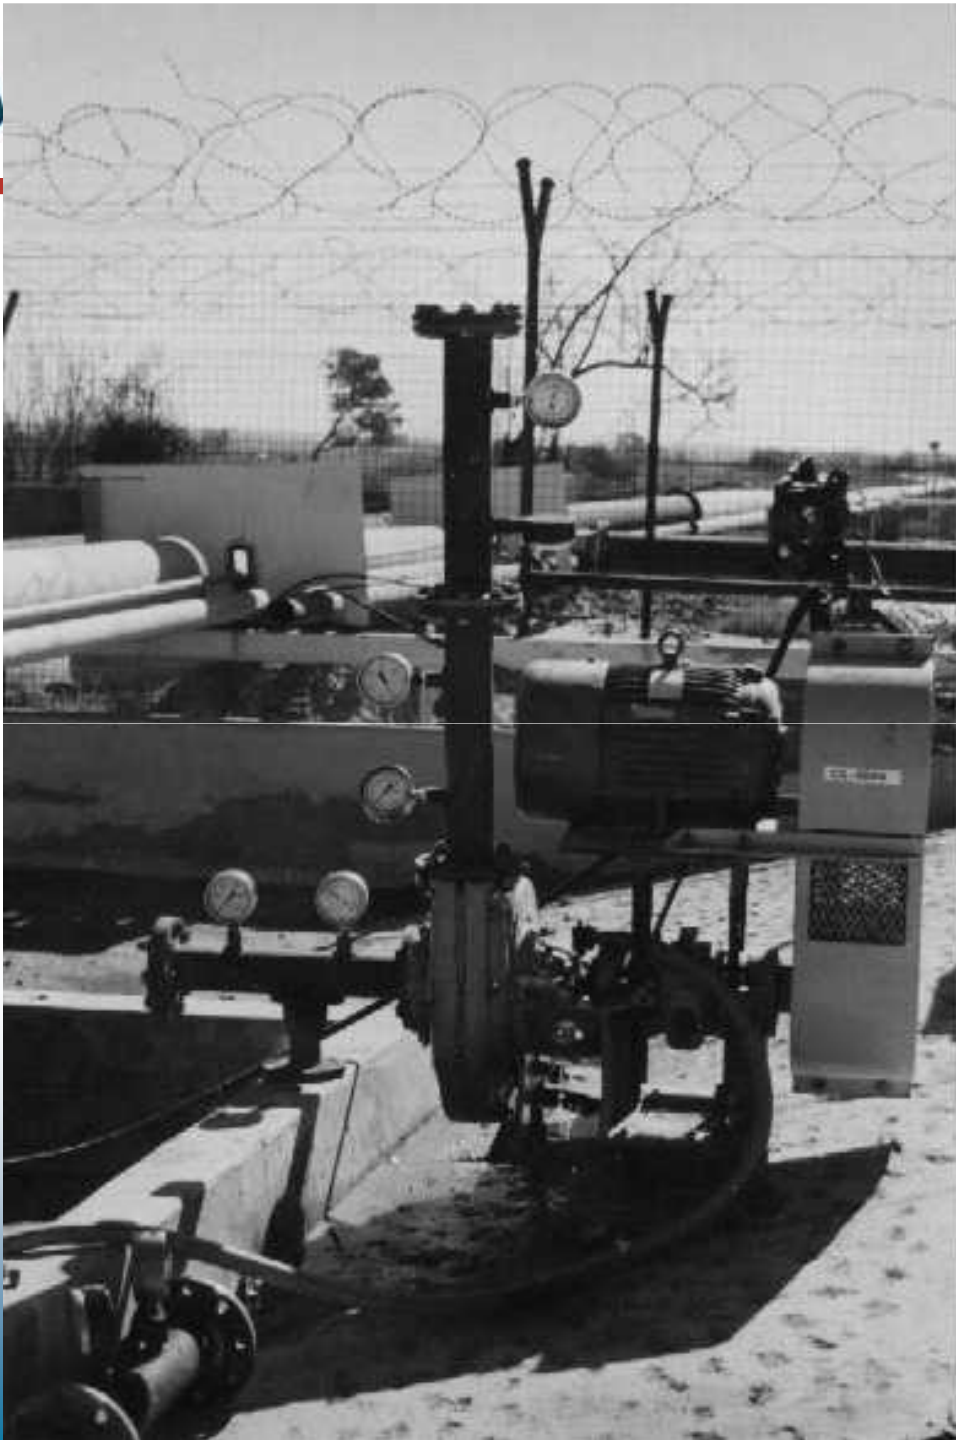
Pump frame size:	AB
Pump type;	Rubber lined with rubber lined impeller
Casing volume:	10 litres
Pipe section volume:	2.5 litres per 500mm section
Motor rating;	11 kW
Motor speed:	1 470 rpm
Motor rated amps:	15 Amps
Motor voltage:	525 V three phase
No load current:	5 Amps
Pump speed:	1 140 rpm
Suction diameter:	80 mm
Delivery diameter:	75 mm
Casing pressure rating:	850 kPa
Casing factor of safety:	2.5 from manufacturer
Number and grade of casing bolts:	9 x Grade 4.6
Bolt diameter:	12 mm

Test pump with 500 mm suction and 1 000 mm delivery

In order to try ascertain what actually happens within the casing of a centrifugal pump, a test pump was rigged up with suction and delivery sections of 500 mm each. Each section was fitted with a pressure and temperature gauge.
