Centrifugal Pump Explosions

“Rise of the machines”

Brian P. O’Connor

16 March 2006

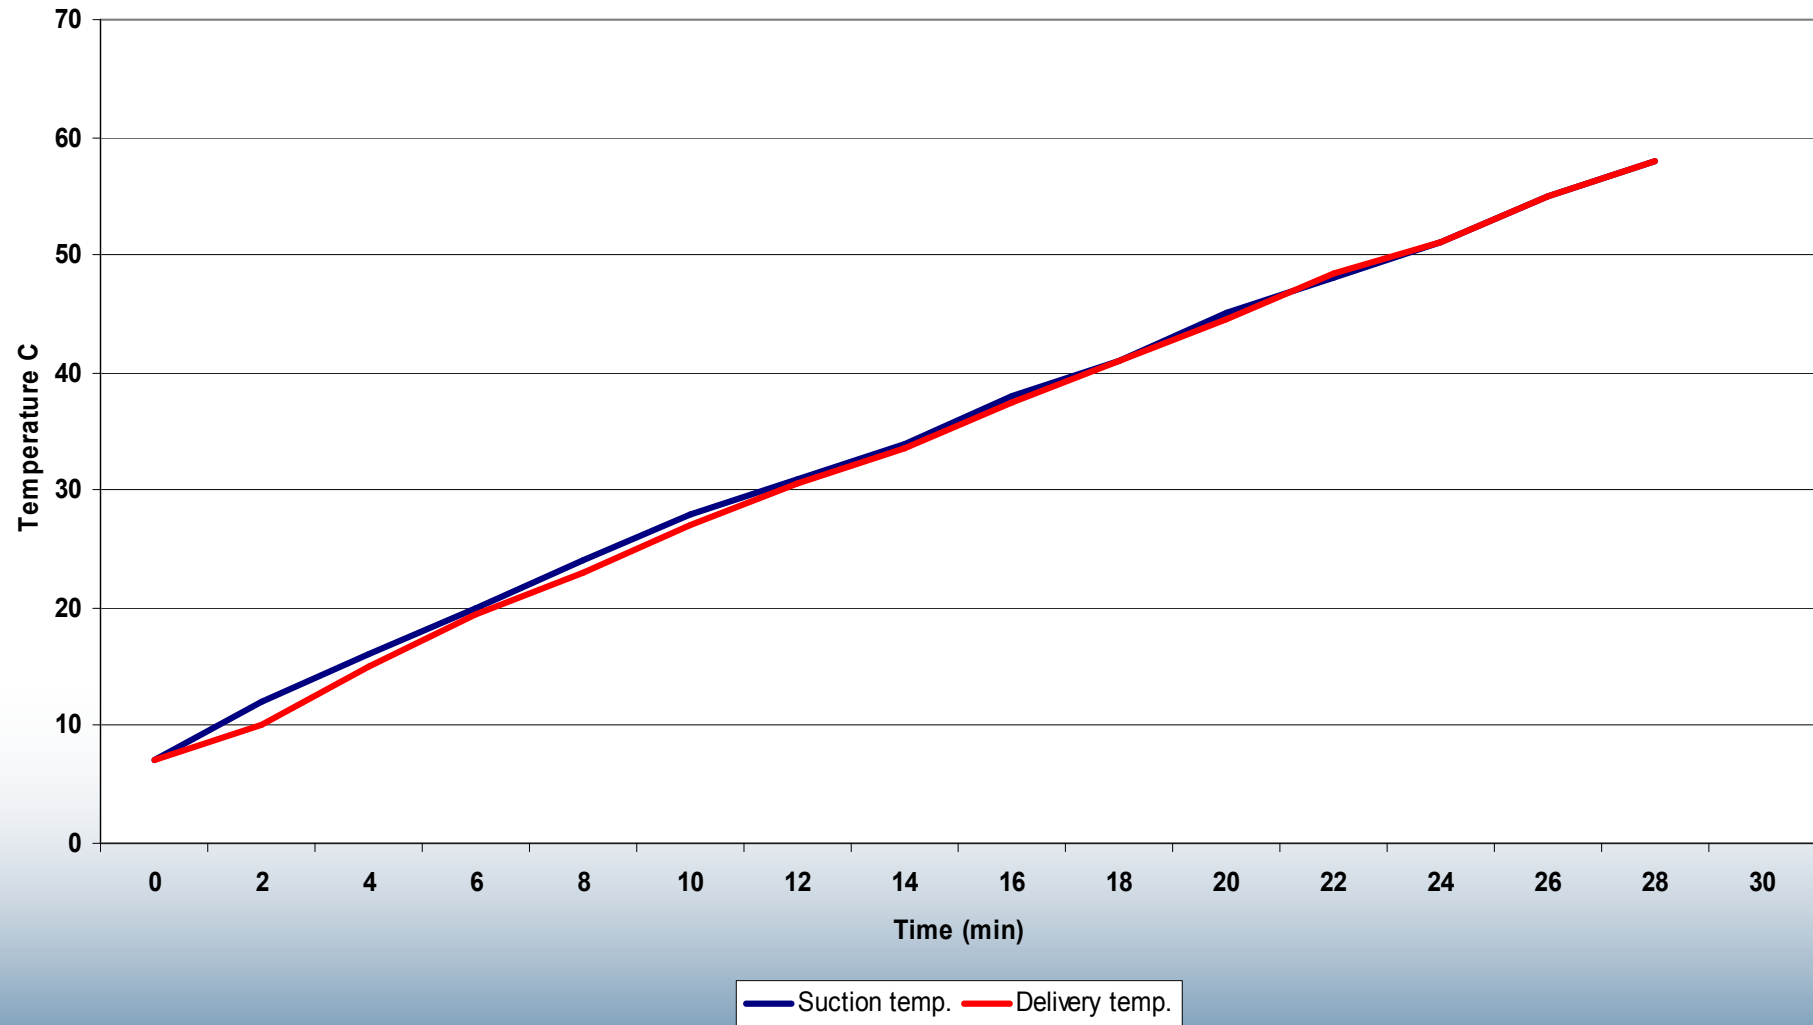
Test 1 - 500mm suction and 500 mm delivery

Test 1 results

$$\text{Total power transferred to fluid} = 0.317 + 1.269 + 0.317 = 1.9 \text{ kW}$$

$$\text{Electrical power} = 1.732 \times 525 \times 7.3 \times 0.8 = 5.31 \text{ kW}$$

$$\text{Percentage of motor power transferred to fluid} = 35.8\%$$

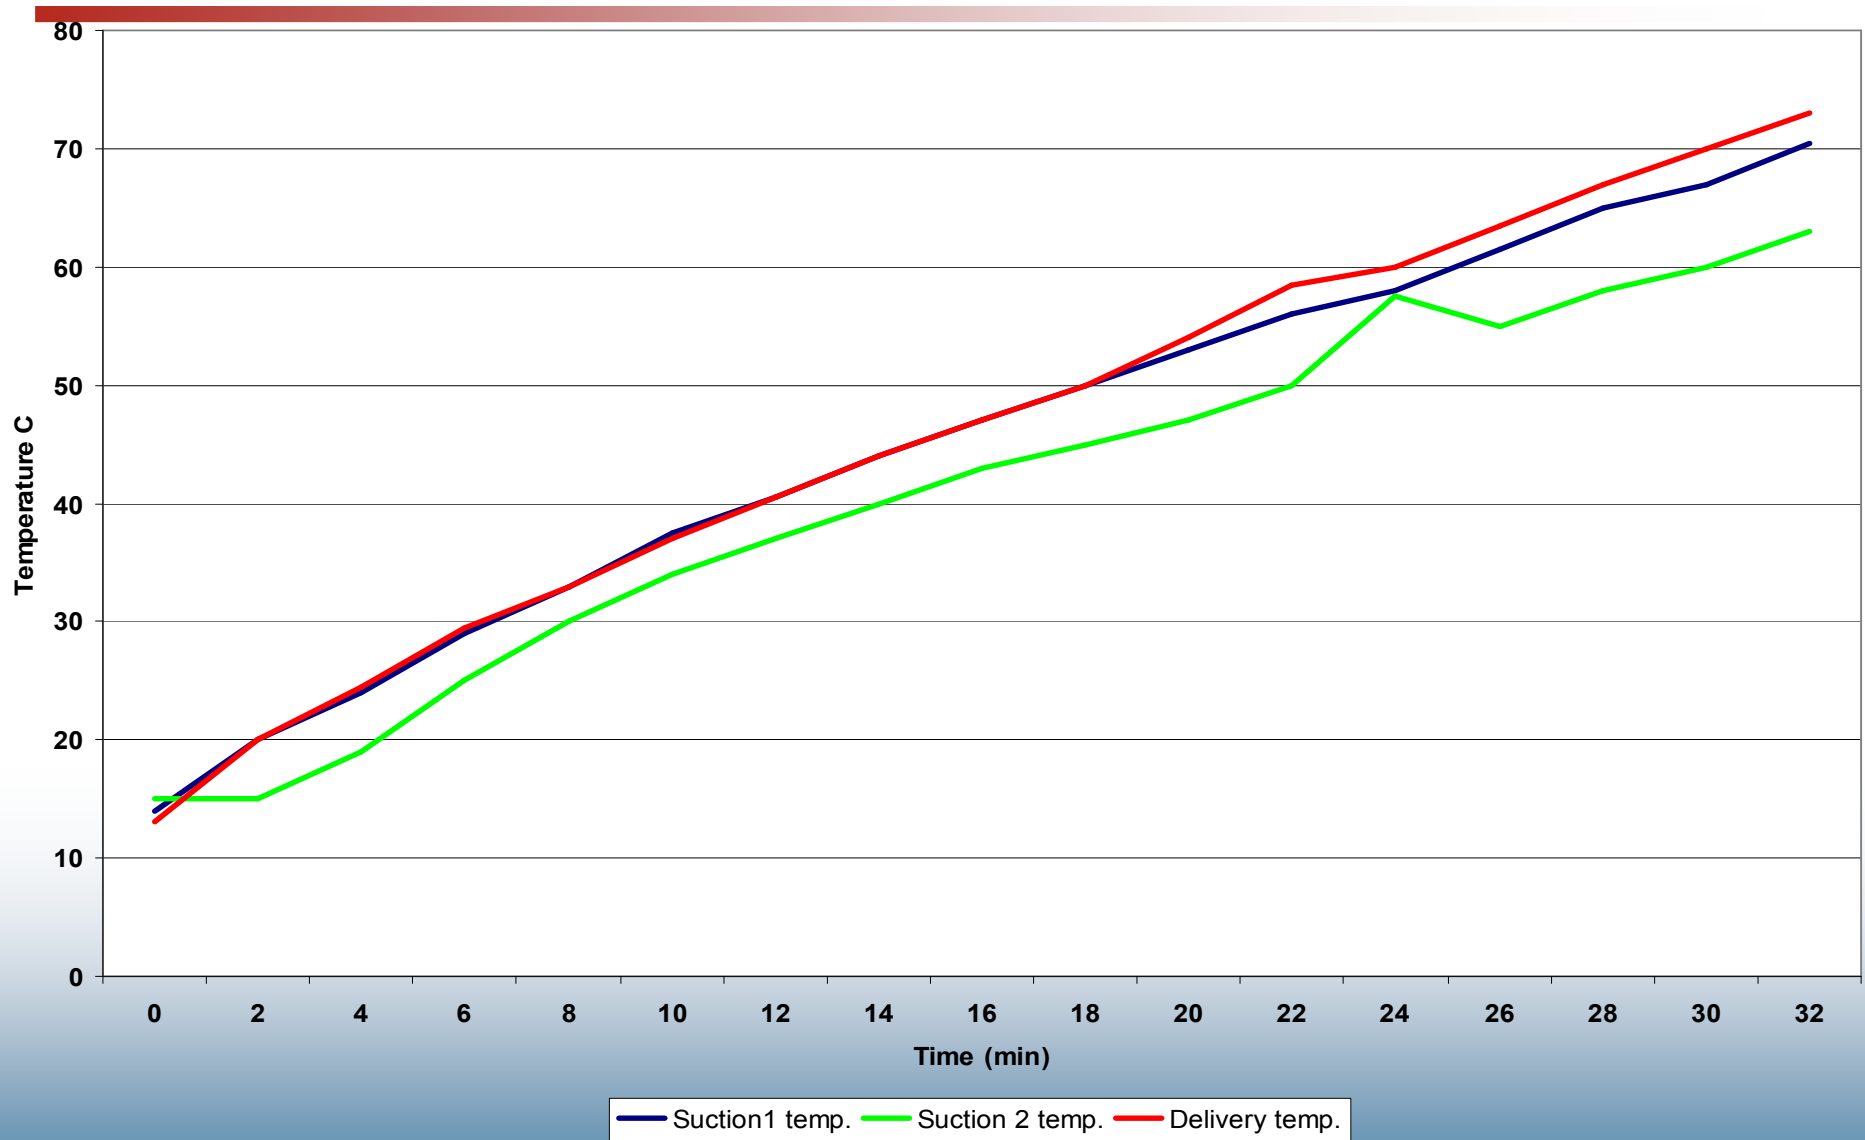
Test 2 - 1 000mm suction and 500 mm delivery

Total power transferred to fluid

$$\begin{aligned}\text{Power} &= 0.308 + 0.261 + 0.327 + 1.263 \text{ kW} \\ &= 2.159 \text{ kW}\end{aligned}$$

$$\text{Percent electrical power transferred to fluid} = 41.2\%$$

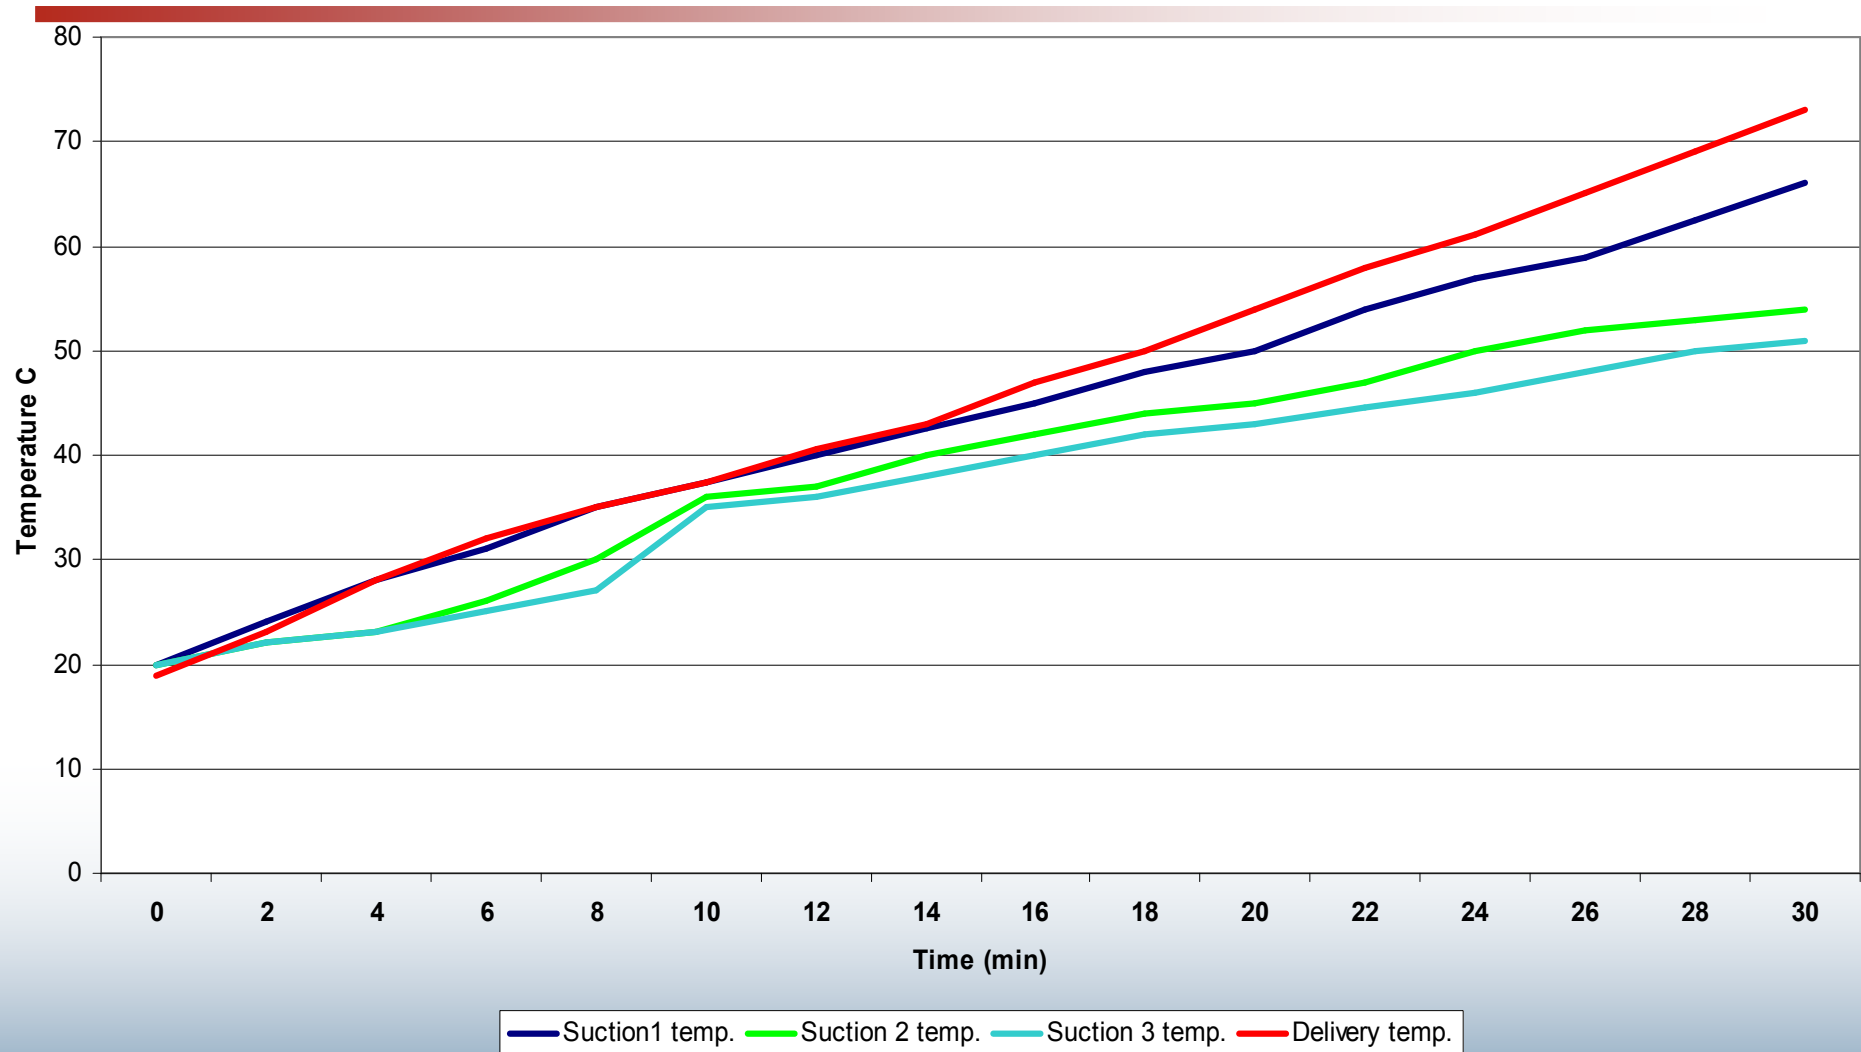
Test 3 - 1 500mm suction and 500 mm delivery

Total power transferred to fluid =

$$\begin{aligned} \text{Power} &= 0.267 + 0.197 + 0.18 + 0.314 + 1.161 \text{ kW} \\ &= 2.119 \text{ kW} \end{aligned}$$

Percentage heat transferred to fluid = 41.03%

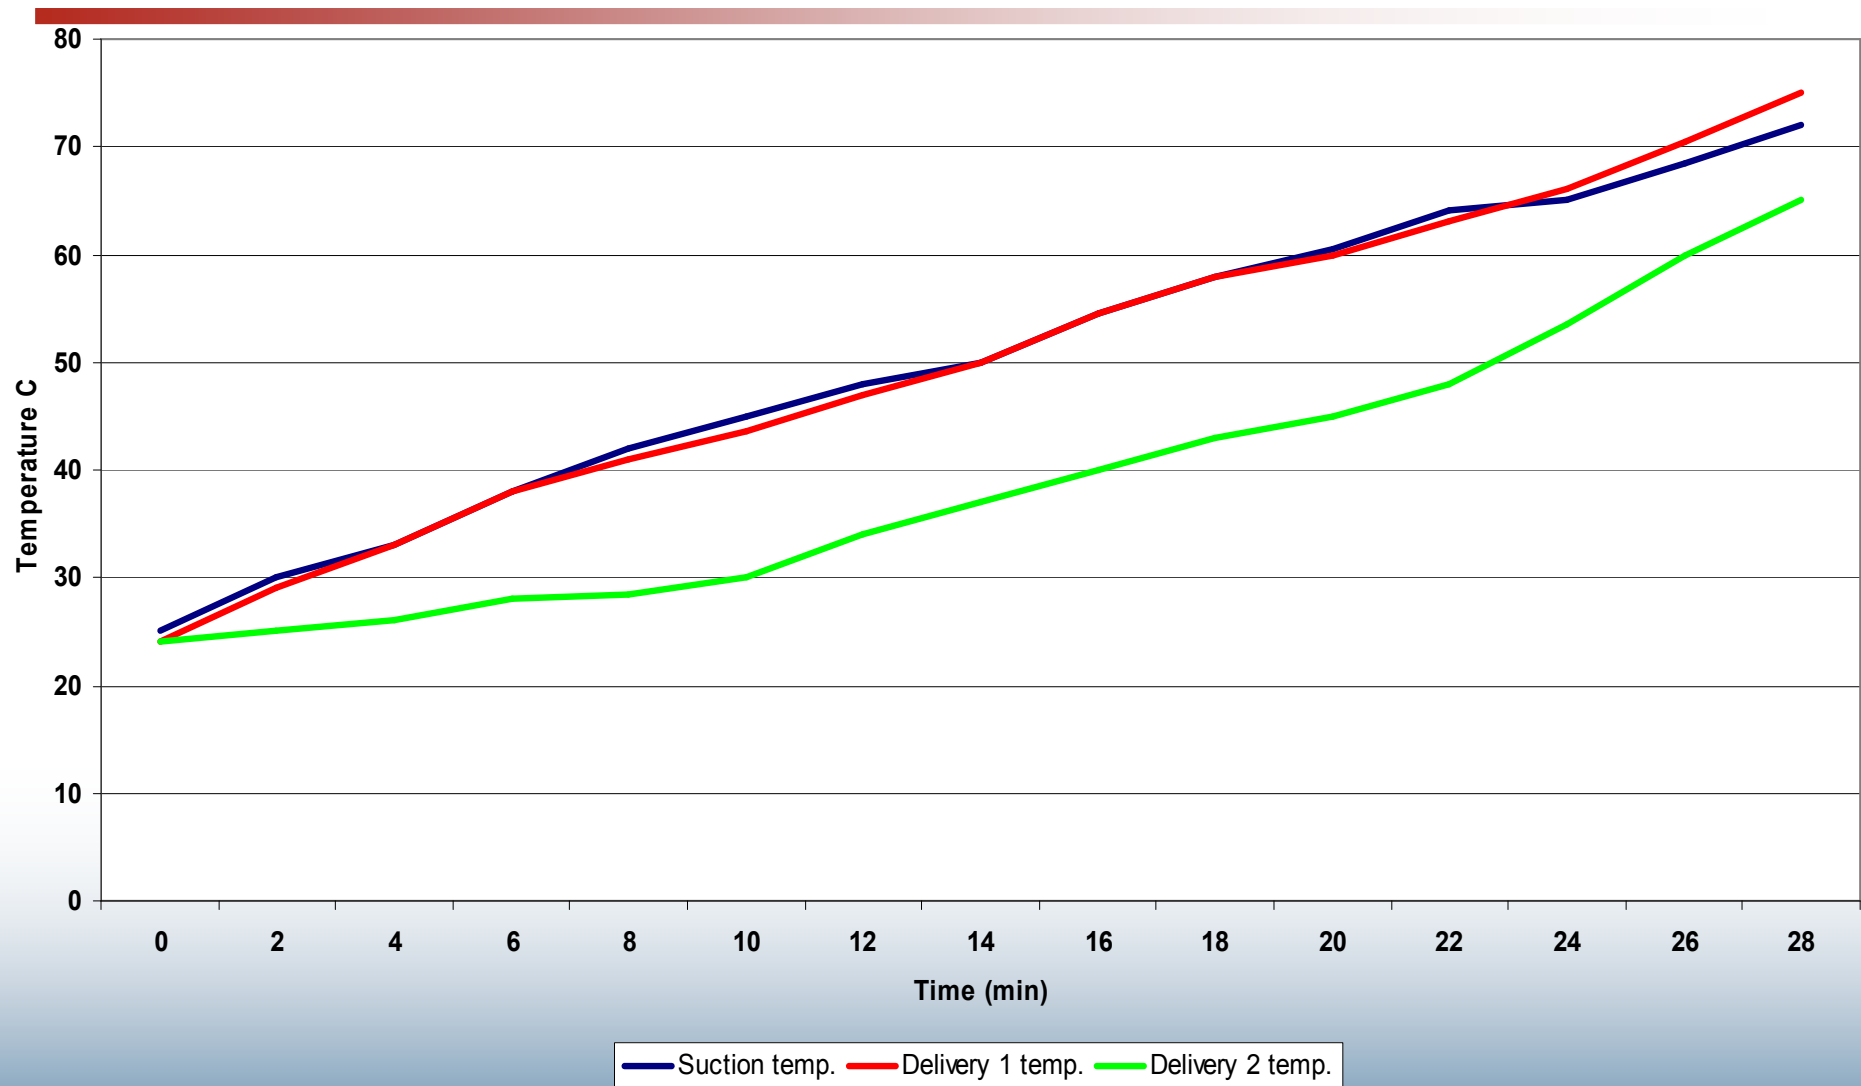
Test 4 - 500mm suction and 1000 mm delivery

Power transferred to fluid

$$\begin{aligned}\text{Power} &= 0.292 + 0.317 + 0.255 + 1.219 \text{ kW} \\ &= 2.084 \text{ kW}\end{aligned}$$

$$\text{Percentage transferred to fluid} = 38.2\%$$

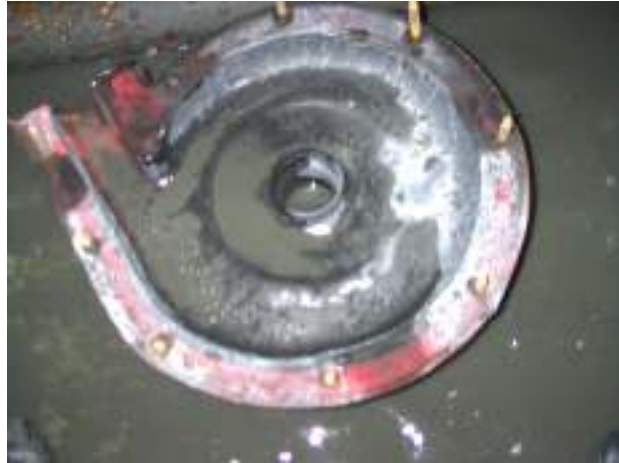
Test case 1 AB carbon transfer pump

The casing is held together with nine grade 4.6 M12 bolts. The casing is rated at 850 kPa with a FOS of 2.5. The projected area of the casing is 145 500 mm².

$$\begin{aligned}\text{Strength of casing} &= 145\,500 \times 850 \times 2.5 \\ &= 309 \text{ kN}\end{aligned}$$

$$\begin{aligned}\text{Strength of bolts} &= 9 \times 113 \text{ mm}^2 \times 240 \text{ MPa} \\ &= 244 \text{ kN}\end{aligned}$$

Bolts failed before the casing. This is a pressure burst not an explosion.

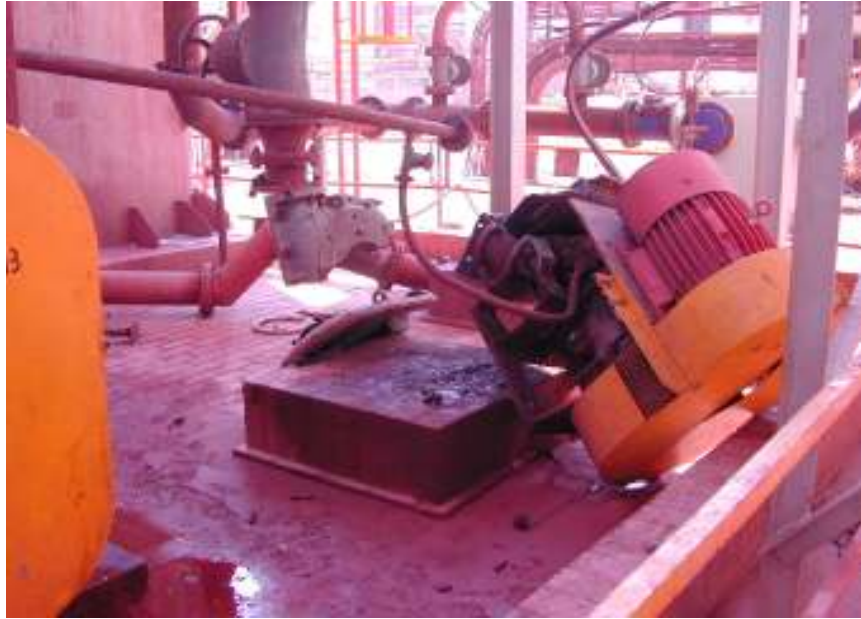
Test case 3 Hot calcine water pump

Feed temperature was 70 C.
Specific heat of fluid is 3.71.
Time to start boiling = 20 mins.

Time to failure = 2 ³/₄ hours

Casing force at failure = 370 kN.

Shear strength of front two M16 bolts = 30 kN

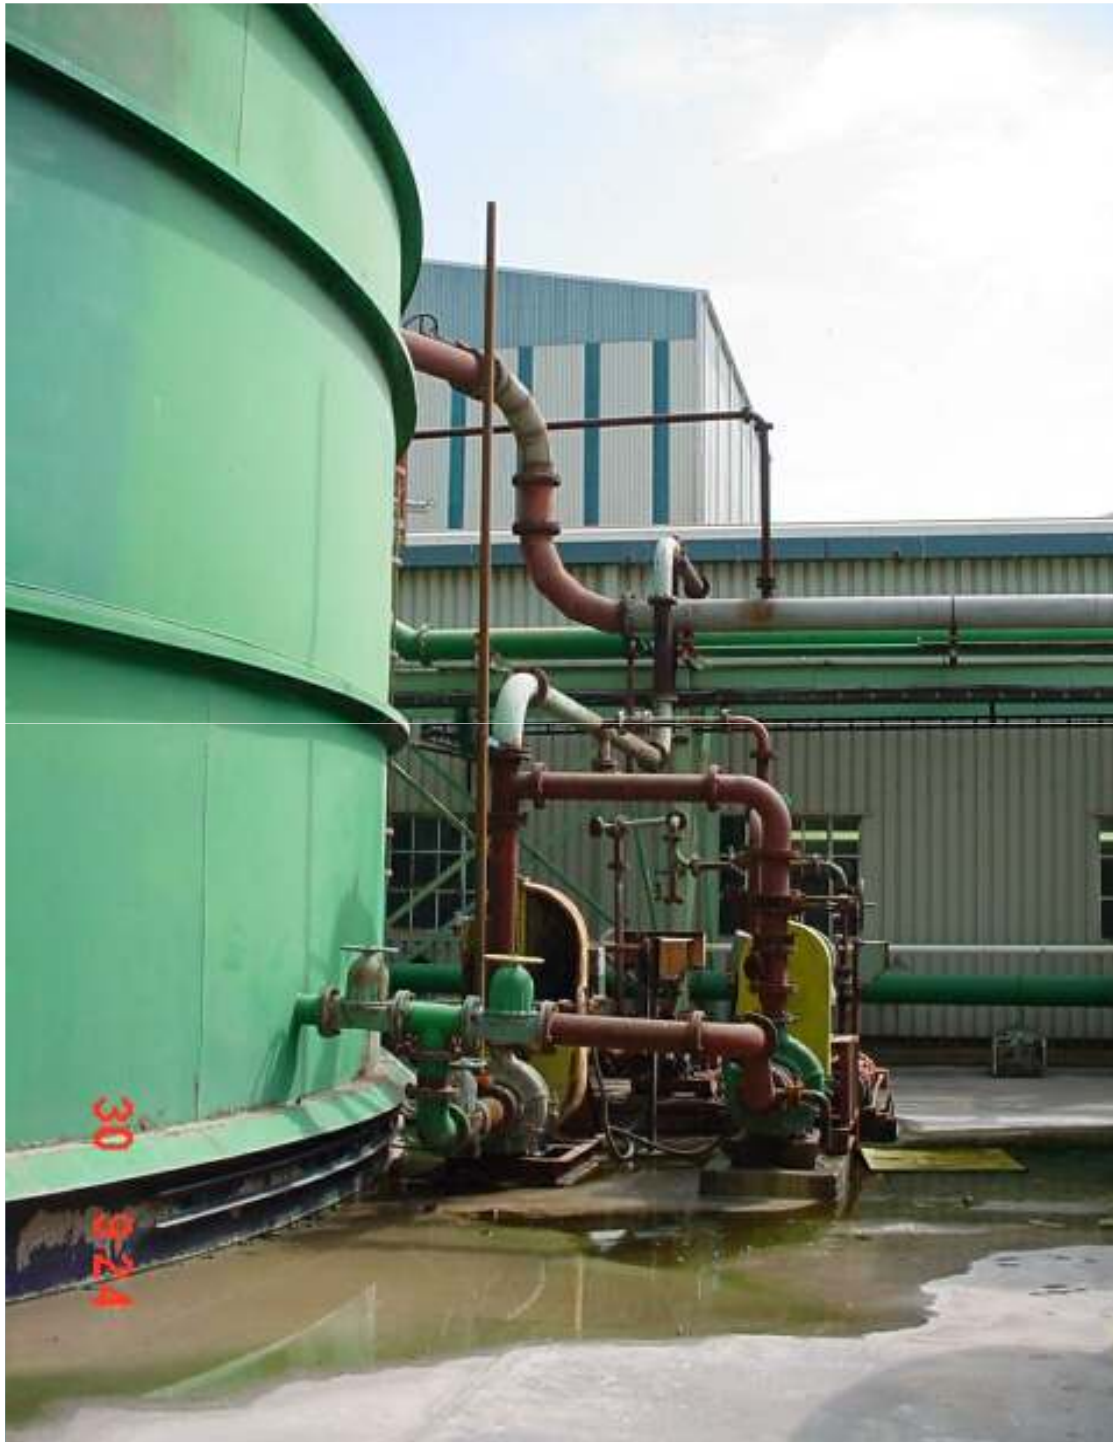
The simpler solution a stand pipe!

Centrifugal pump with
stand pipe fitted

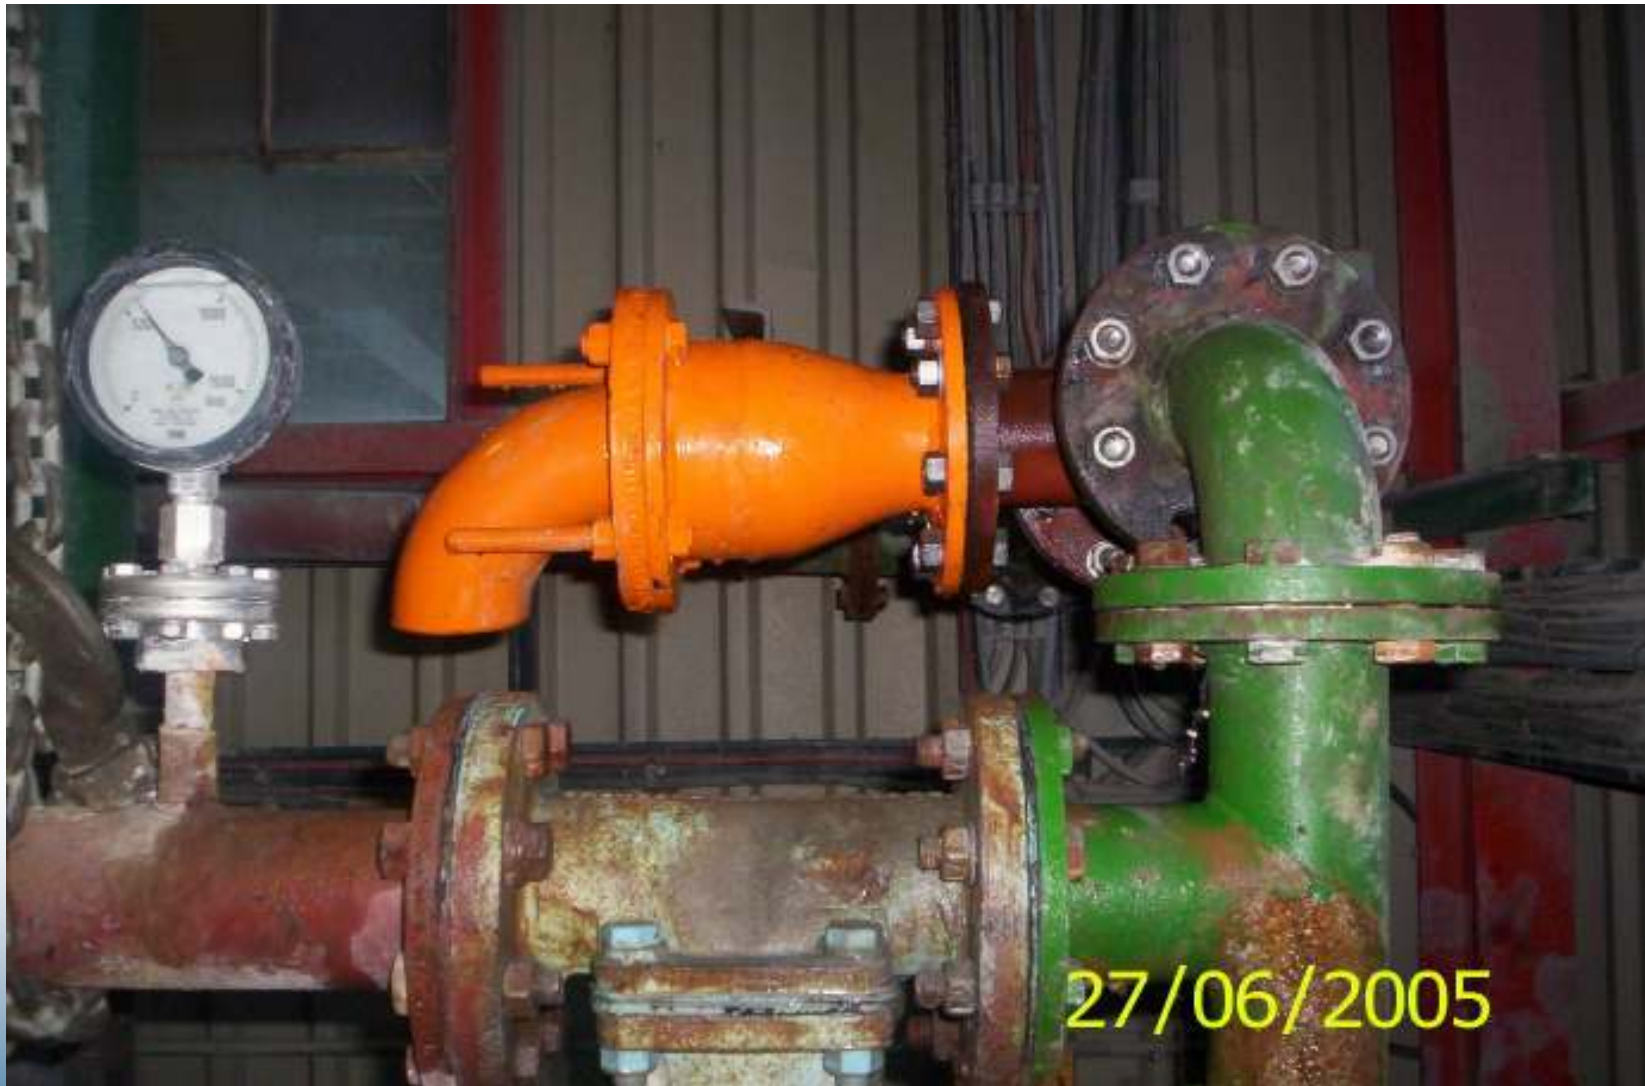
Home made pressure relief valves fitted (Photo).
